Home Inspection Report

123 Sample Lane

Sample , KY 12345

Inspected on Thu, Jul 19 2018 at 8:00 AM

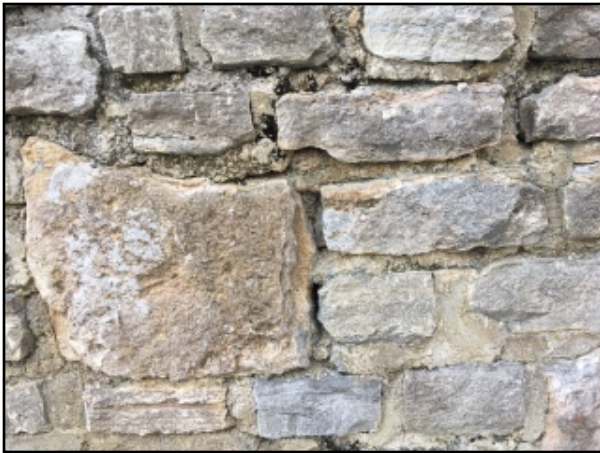
Figure 7-1

Loose/missing mortar - Recommend an experienced mason seal cracks and replace missing mortar to prevent further damage due to freeze/thaw cycle.

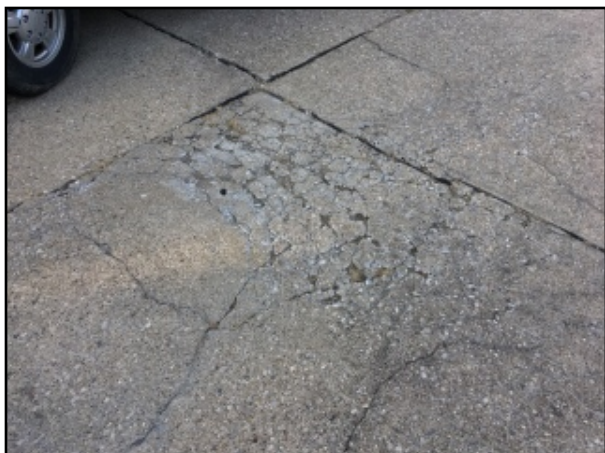
Figure 8-1

Crumbling concrete - Concrete crumbling due to failure of subgrade bearing strength. Possibly due to expansive soils, saturated soil and/or lack of compacted gravel. Recommend repair.

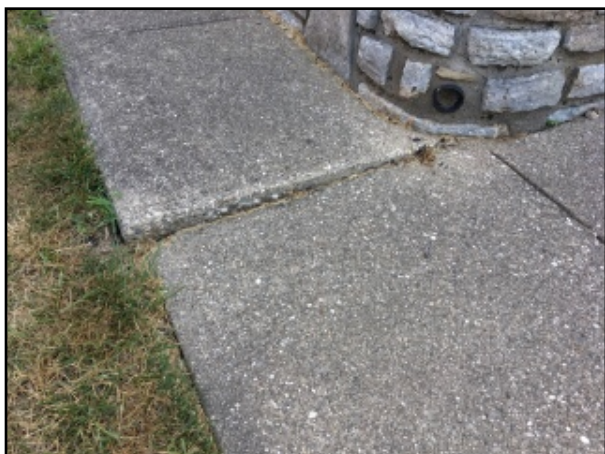
Figure 9-1

Sidewalk trip hazard/s - safety concern especially for the elderly and children. Recommend replacement, grinding or concrete lifting to eliminate this hazard.

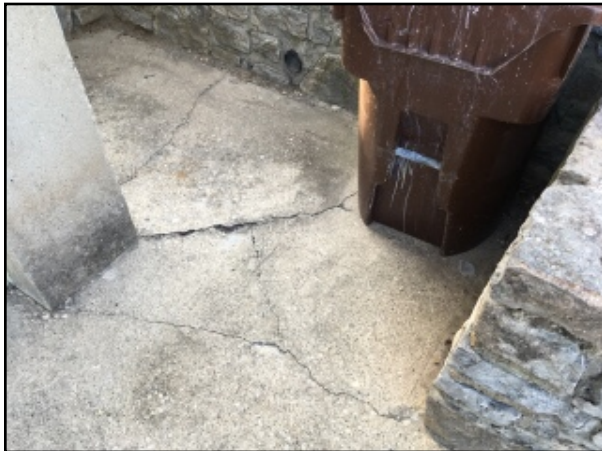
Figure 11-1

Lack of control joints - Cracks in concrete as a result of insufficient control joints, normally placed at time of installation. Recommend sealing cracks to prevent further damage as a result of freeze/thaw cycles as well as degradation of the subgrade due to water saturation.

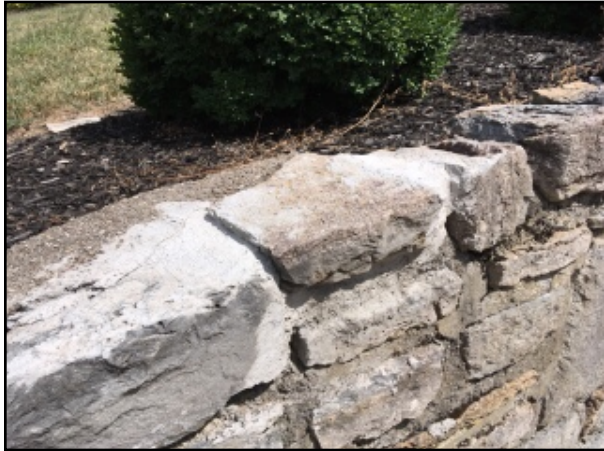
Figure 12-1

Loose retaining wall stone/s-recommend an experienced mason make repairs.
Evidence of prior repair.

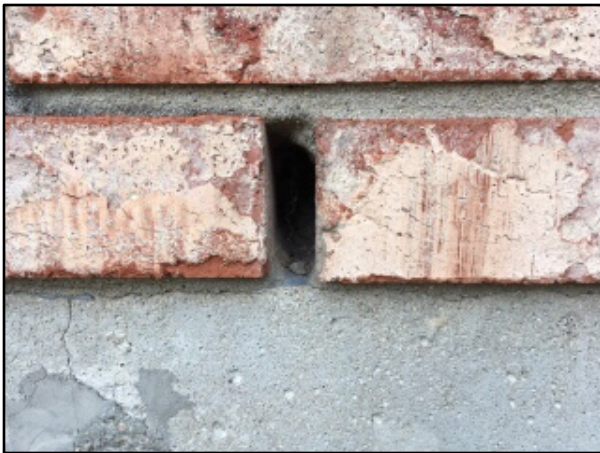
Figure 13-1

These are weep holes which allow moisture to drain from behind brick. Recommend stuffing with stainless steel wool to keep rodents and other pests out.

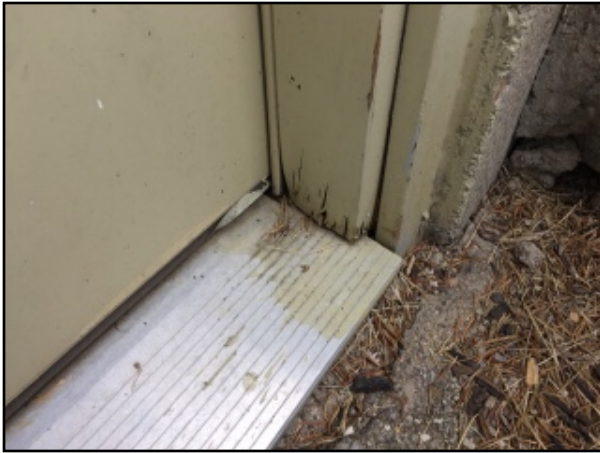
Figure 16-1

Wood door jamb deterioration - recommend repair or replace. Loose hinges/sagging door - door strikes jamb and does not shut smoothly. Recommend repair.

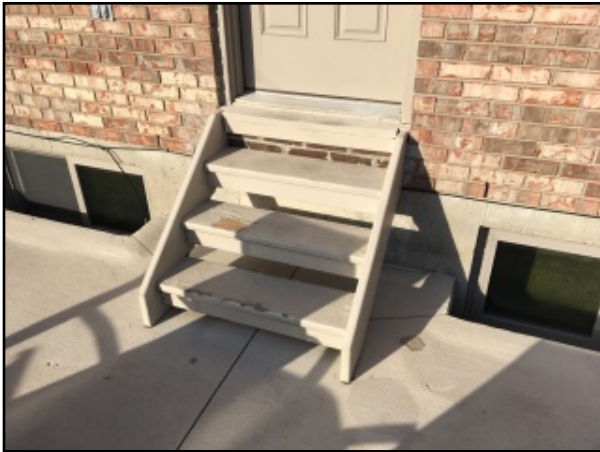
Figure 18-1

Missing handrail - with three or more steps, a handrail is recommended. The elderly and/or children may find difficulty in using the steps safely. Able bodied people may also find difficulty during times of freezing precipitation when the steps may be slippery. Recommend adding a railing.

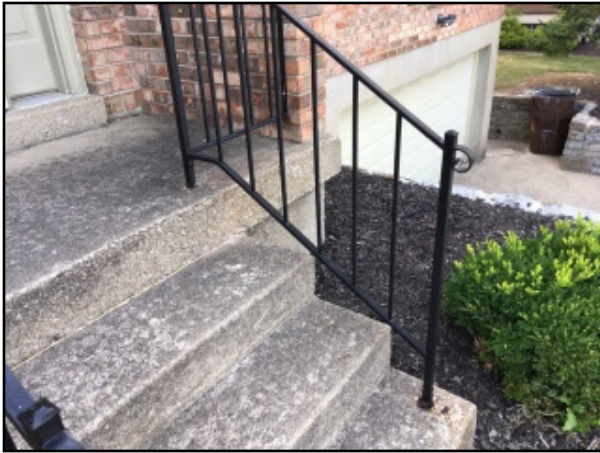
Figure 19-1

Rusty railing posts - The bottom of the railing posts are rusting away causing the railing to lose strength. Recommend repair or replace.

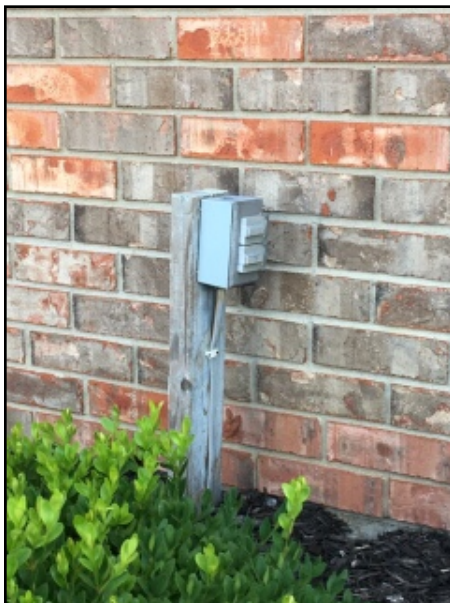
Figure 20-1

No power at exterior outlet. Unable to test for ground fault circuit interrupting device protection. Recommend inquiring with homeowner as to whether there may be a switch or an unlocated GFCI outlet that was already tripped. Recommend weatherproof-while-in-use type "bubble" cover. See photo example.

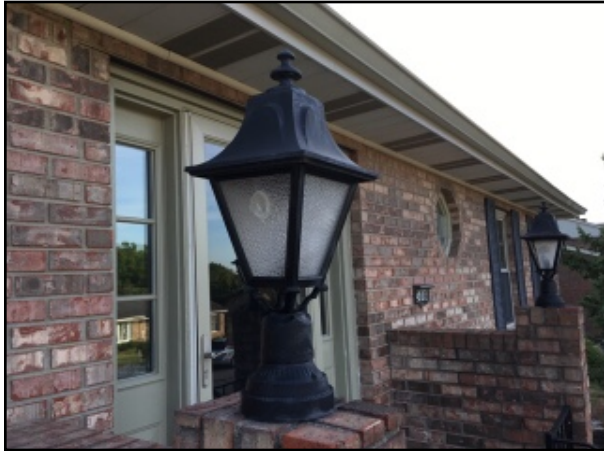
Figure 21-1

**Comment 21:**
Melted light fixture len/s- Likely a bulb of too high of wattage was used, and overheated the len/s. Recommend replacement.

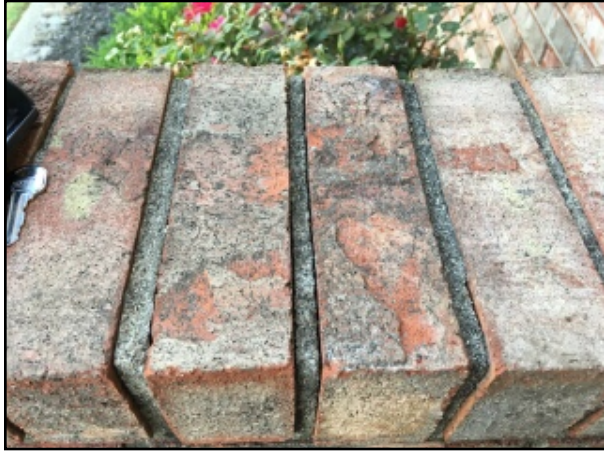
Figure 22-1

**Comment 22:**
Loose/missing mortar - Recommend an experienced mason seal cracks and replace missing mortar to prevent further damage due to freeze/thaw cycle.

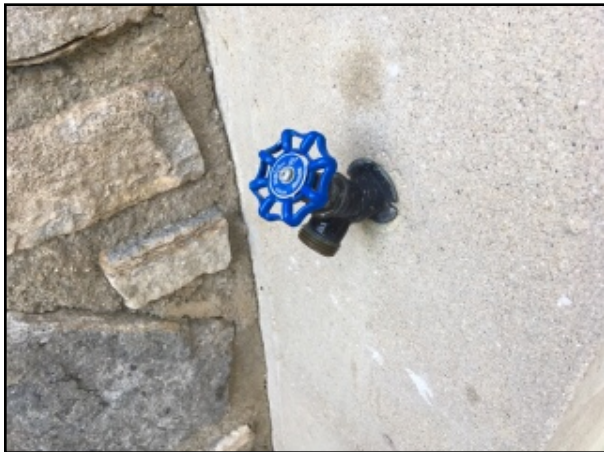
Figure 23-1

Exterior hose bib/s - Not frostproof type hose bib/s, and will require interior valve/s counterparts to be shut and outdoor valve/s to be opened in order to drain trapped water prior to freezing temperatures to prevent damage to the valve.

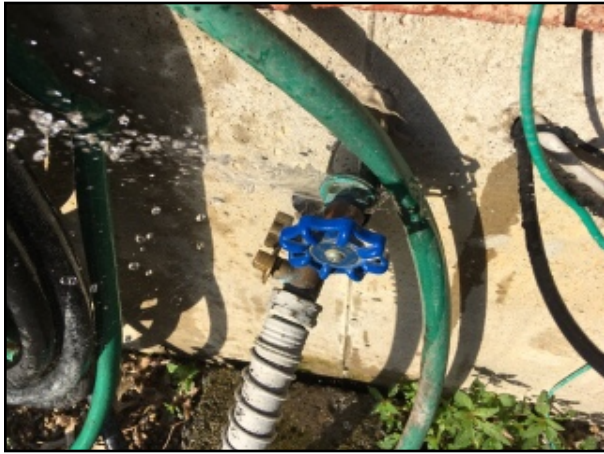
Figure 24-1

Leaking exterior hose bib. Recommend repair or replace by a qualified plumber.

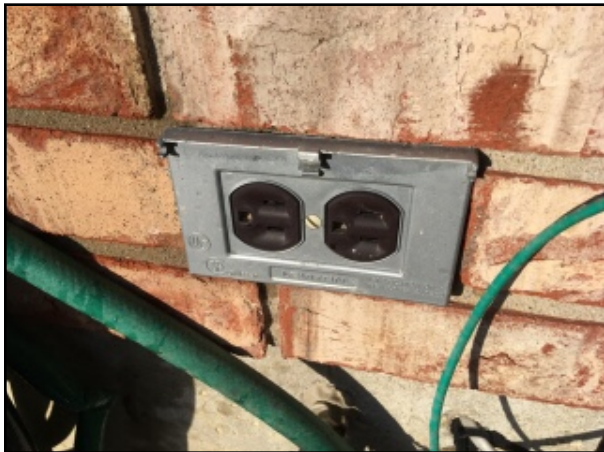
Figure 25-1

No outlet cover - Exterior outlet missing cover. No power at exterior outlet. Unable to test for ground fault circuit interrupting device protection. Recommend inquiring with homeowner as to whether there may be a switch or an unlocated GFCI outlet that was already tripped. Recommend weatherproof-while-in-use type "bubble" cover. See photo example.

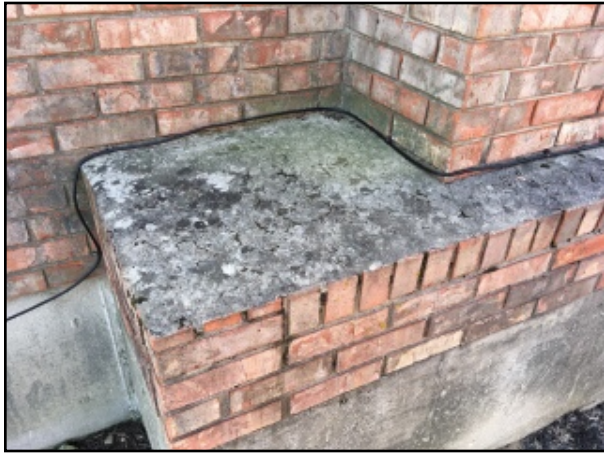
Figure 27-1

Vulnerable chimney shoulder/s - Top of chimney shoulder is not sloped. Water can soak in and deteriorate the shoulder/s through freeze/thaw cycles. Recommend cleaning and sealing or increasing the slope of the chimney shoulder/s.

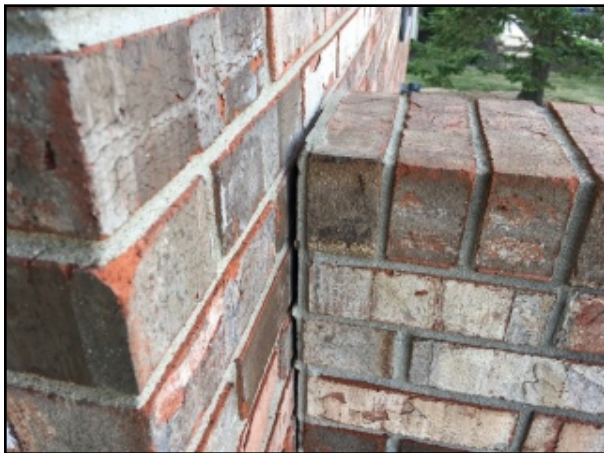
Figure 28-1

Open joint - recommend sealing with flexible caulking to prevent damage from freeze/thaw cycles.

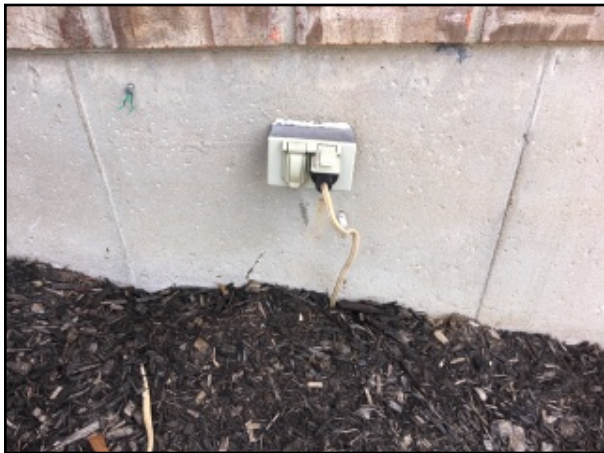
Figure 29-1

No power at exterior outlet. Unable to test for ground fault circuit interrupting device protection. Recommend inquiring with homeowner as to whether there may be a switch or an unlocated GFCI outlet that was already tripped. Recommend weatherproof-while-in-use type "bubble" cover. See photo example. Also, recommend removing the homemade extension cord that runs through the mulch and across the top step. UV light will degrade the shielding, possibly exposing wires and if landscaping work is to be done, a shovel cutting through it would be detrimental to both the wire and the shovel operator.

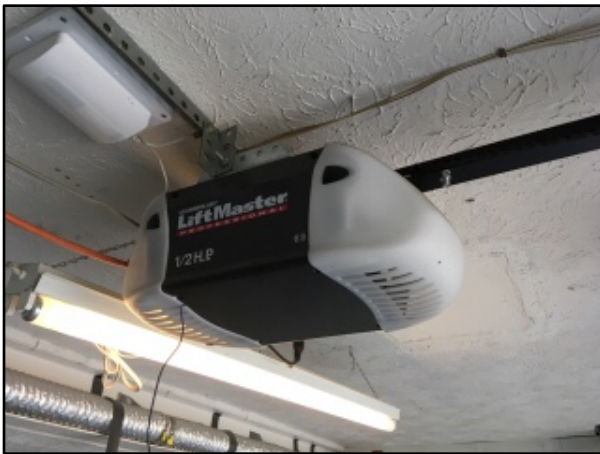
Figure 30-1

Comment 30:
Non-functioning garage door opener lights - bulbs may be burnt out.
Recommend replacing bulbs.

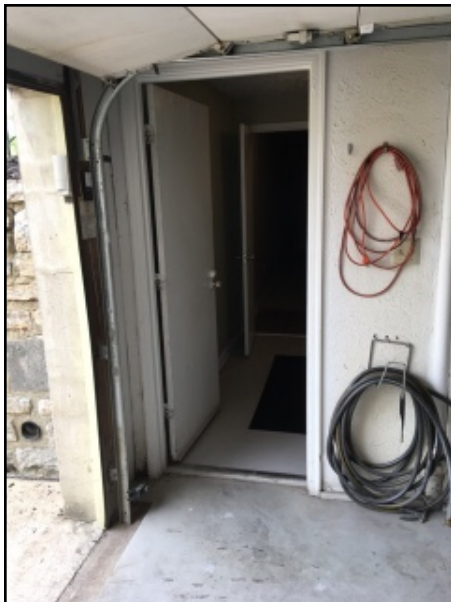
Figure 34-1

Non-self closing hinges - Recommend self closing hinges on the door to the garage so that the door is not accidentally left open allowing fumes, smoke or fire from the garage to easily migrate into the house.

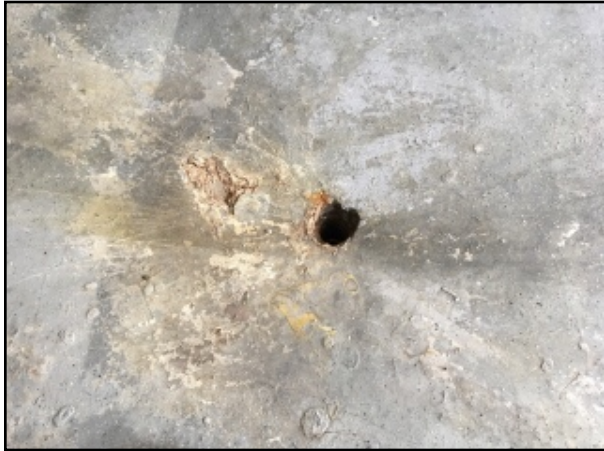
Figure 35-1

Missing grate on floor drain. Recommend finding one to fit to prevent unwanted loss of small dropped items.

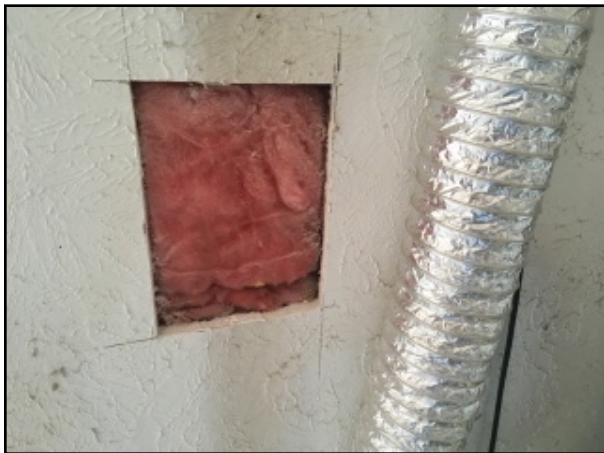
Figure 36-1

Gap in fire separation - The garage should be separated from the house by continuous drywall in order to slow the spread of fire. Additionally, these gaps allow fumes and dust from the garage into the house. Recommend sealing these gaps.

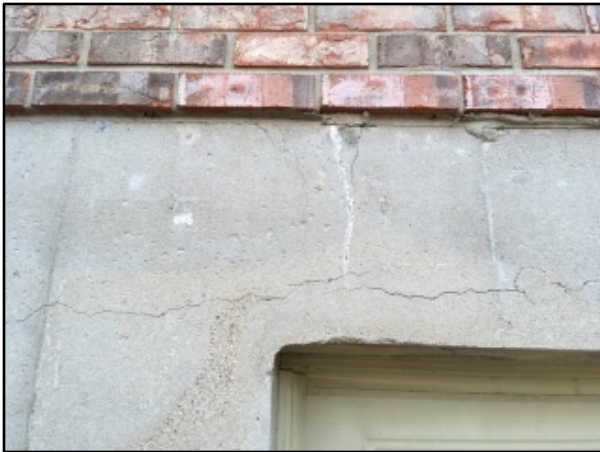
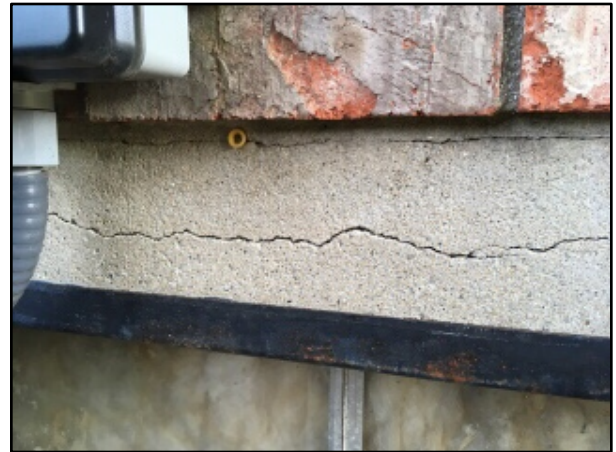
Figure 40-1

Minor foundation cracks - Recommend monitoring for change in size and seal the crack to prevent damage from freeze/thaw cycles.

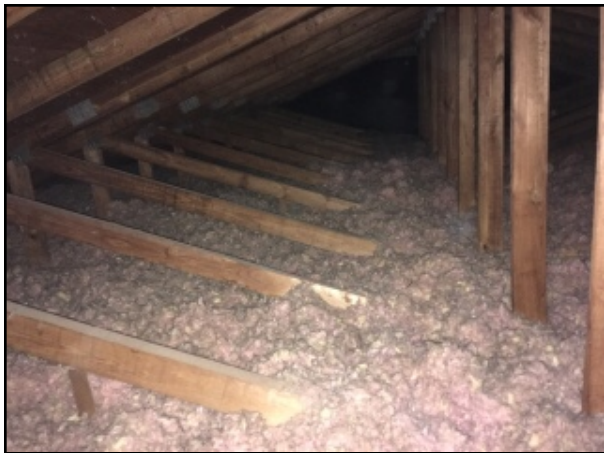
Figure 43-1

Displaced attic insulation - The insulation was displaced in several areas of the attic. Likely as a result of renovations. Recommend re-replacing insulation to maintain thermal envelope.

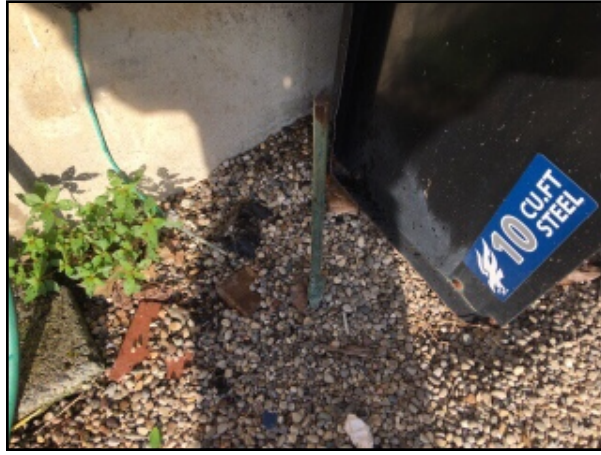
Ground rod can be driven further into the ground so it is less of a trip hazard.

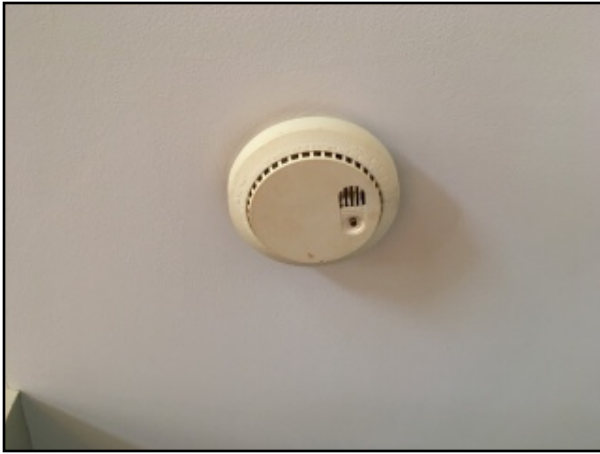
Figure 47-1

Comment 47:
Recommend replacing smoke detectors.

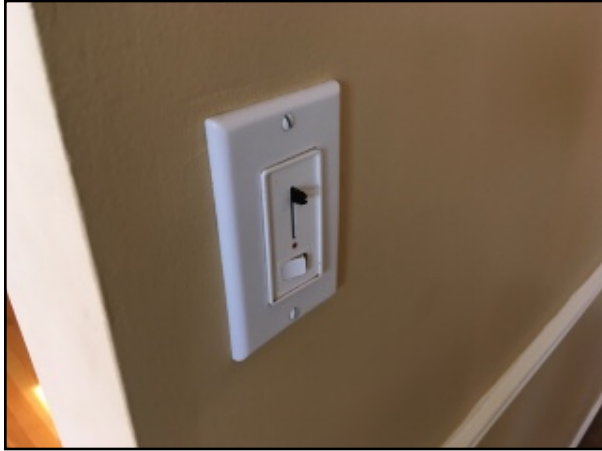
Figure 49-1

Comment 49:
Missing dimmer knob.

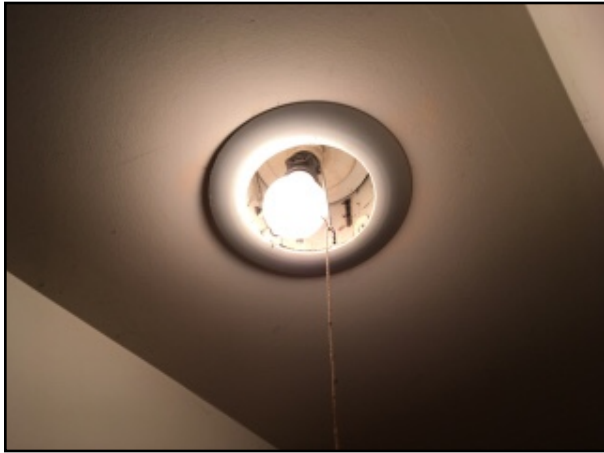
Figure 50-1

Non-IC rated recessed lighting - recessed lighting with an attic above should be insulation contact rated to protect the fixture from overheating when covered directly with insulation. IC rated fixtures are sealed to prevent air/dust migration between the attic and the house. Recommend replacing these recessed light fixtures with IC rated fixtures to prevent energy loss and reduce the risk of fire.

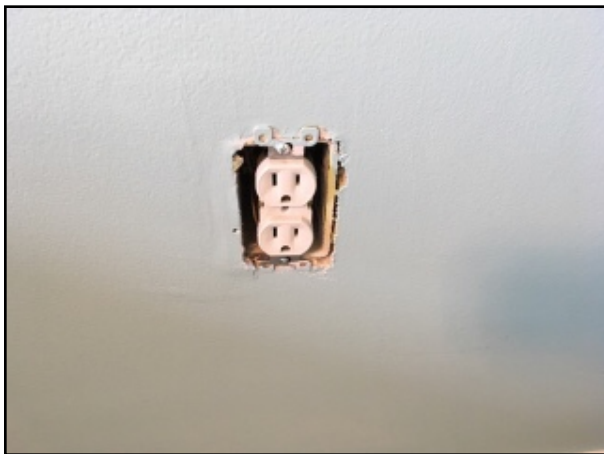
Figure 51-1

Comment 51:
Missing/cracked cover plate/s. Recommend replace.

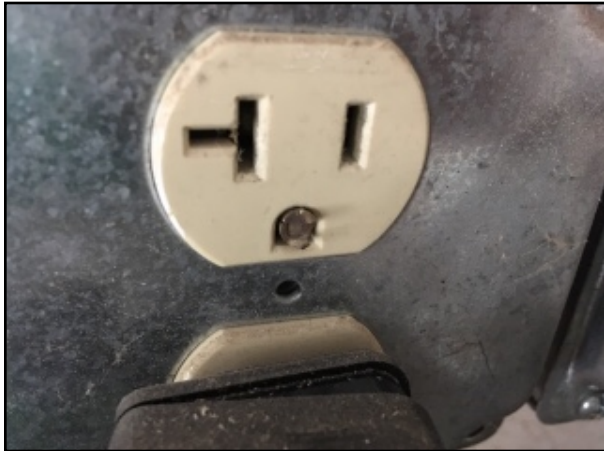
Figure 52-1

Ground prong broken off in outlet. Recommend removal or replacement of outlet.

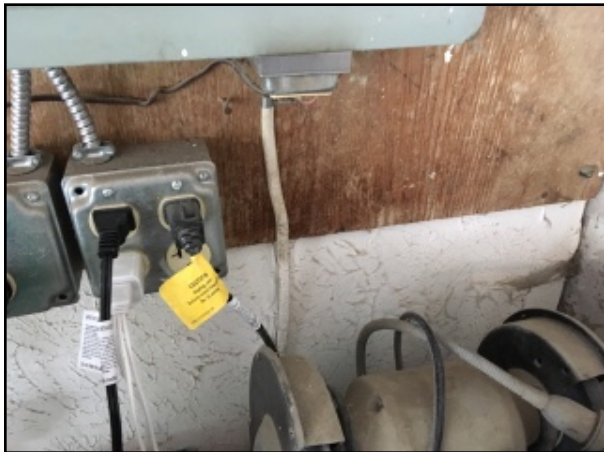
Figure 53-1

Non-metallic shielded wiring run outside of wall - wiring can be easily damaged here, where it is on protected. Recommend qualified electrician install wire inside the wall or inside of a conduit.

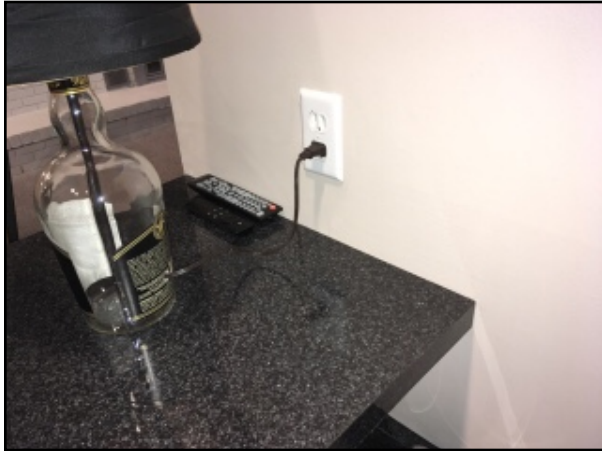
Figure 54-1

**Comment 54:**
Missing GFCI - Non-ground fault circuit interrupting outlet adjacent sink. For electrical safety, recommend replacing with GFCI device.

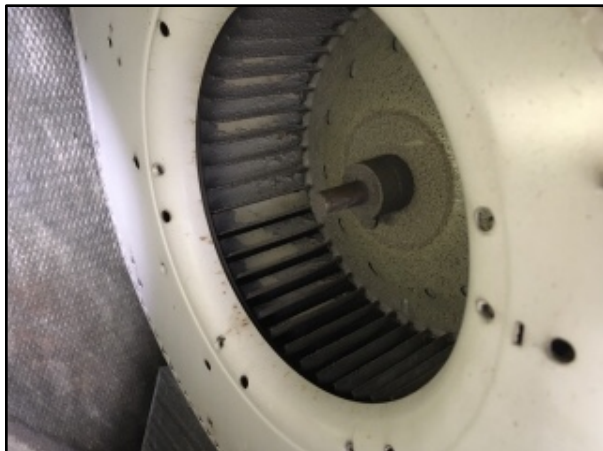
Figure 56-1

Comment 56:
Dirty blower - The blower and interior of the heating and cooling equipment was visibly dirty. Recommend cleaning and servicing by qualified HVAC technician.

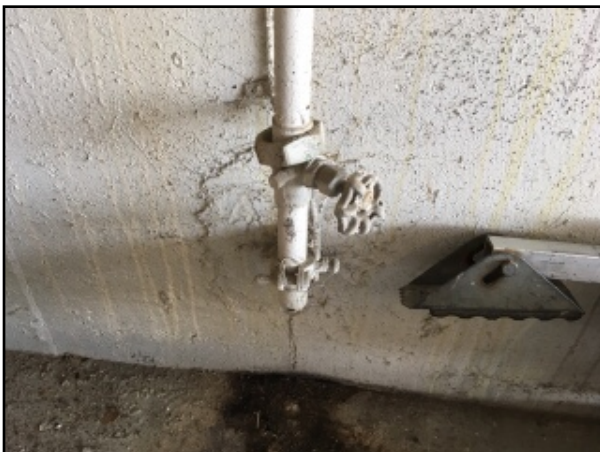
Figure 68-1

Comment 68:
Valve appears to be heavily painted and may not be easily exercised.

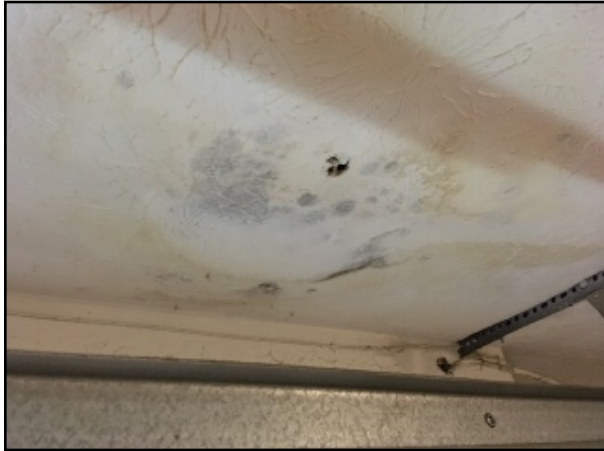
Figure 69-1

Stained and water damaged drywall on ceiling of garage below master bath. Drywall has sagged and shows evidence of possible fungal growth. Tested with moisture meter and found to be currently dry. Check seller's disclosure for knowledge of previous plumbing leaks. Possible concealed damage. Recommend removal of drywall, further inspection for damage to wood structure and drywall repair.

Stained and water damaged drywall on ceiling of garage below master bath. Drywall has sagged and shows evidence of possible fungal growth. Tested with moisture meter and found to be currently dry. Check sellers disclosure for knowledge of previous plumbing leaks. Possible concealed damage. Recommend removal of drywall, further inspection for damage and drywall repair.

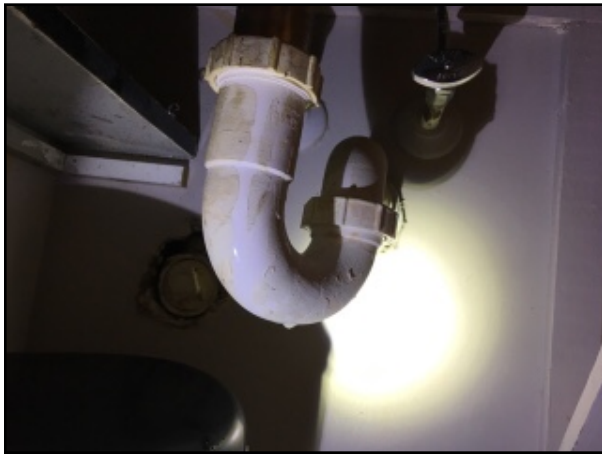
Figure 71-1

Leaking drain at basement bar sink. Recommend repair

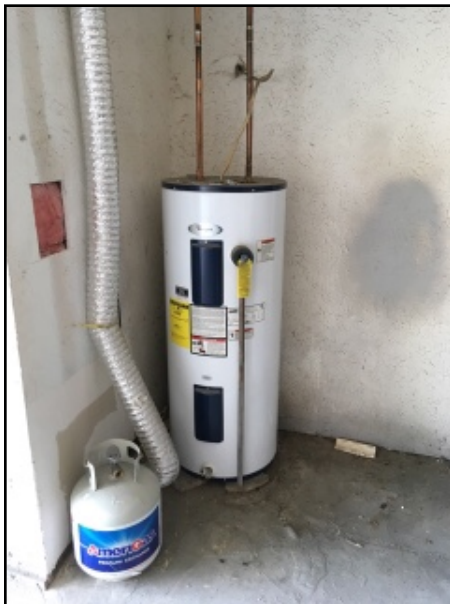
Figure 73-1

Recommend insulating exposed water piping.

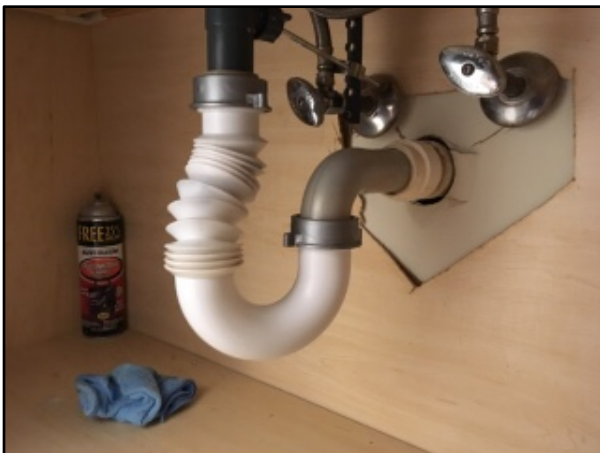
Figure 74-1

Flexible tailpiece extension - these are not recommended as they clog more easily than regular straight piping.

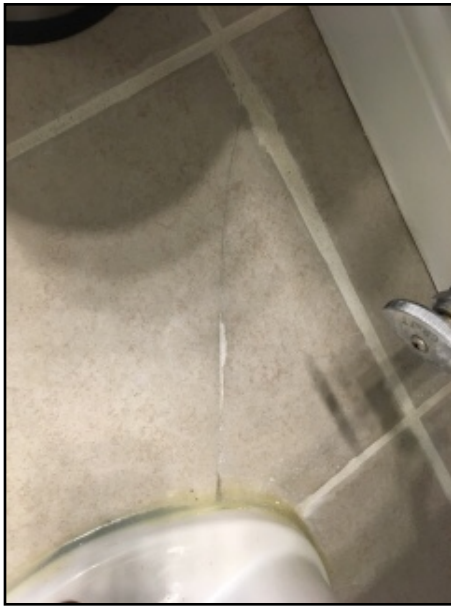
Figure 76-1

Several cracks in floor tile, cracked grout and missing grout/caulking.

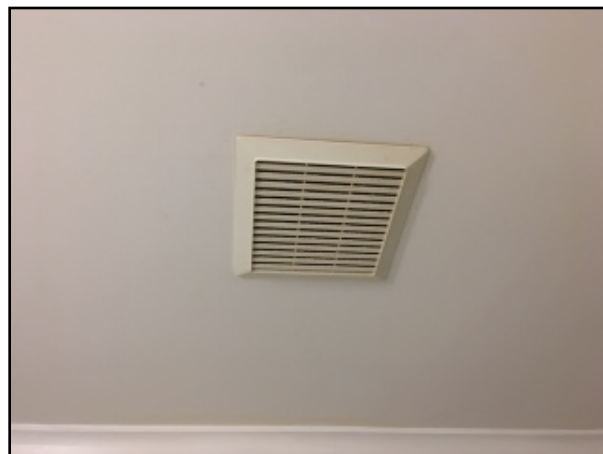
Vents to attic - The bathroom ventilator was discharging into the attic space. This may lead to condensation on attic surfaces and potential fungal growth. It is recommended that bathroom ventilators discharge to the exterior.

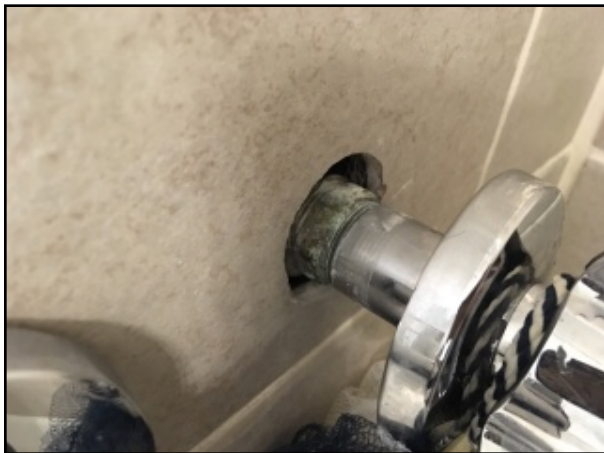
Figure 80-1

Gaps in shower surround at fixture - recommend ceiling gaps with plumbers putty or other sealant to prevent water from penetrating surround and causing hidden damage.

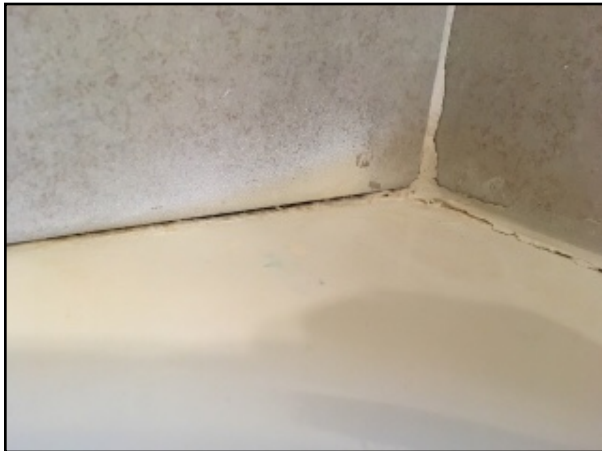
Figure 81-1

White paint-like substance that appears to be overspray from when the tub was refinished. Cosmetic defect.

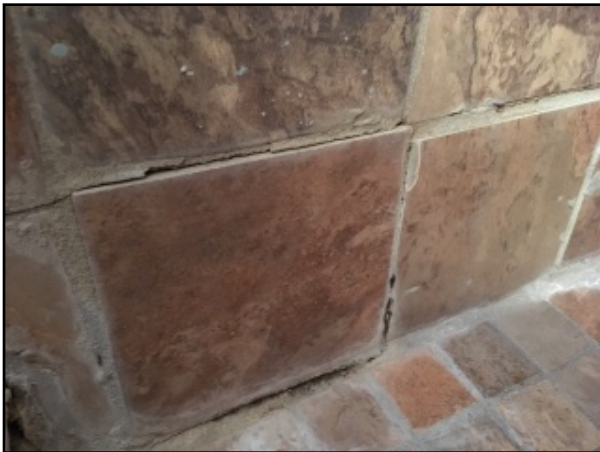
Figure 83-1

Cracked/missing grout - Recommend re-grouting.

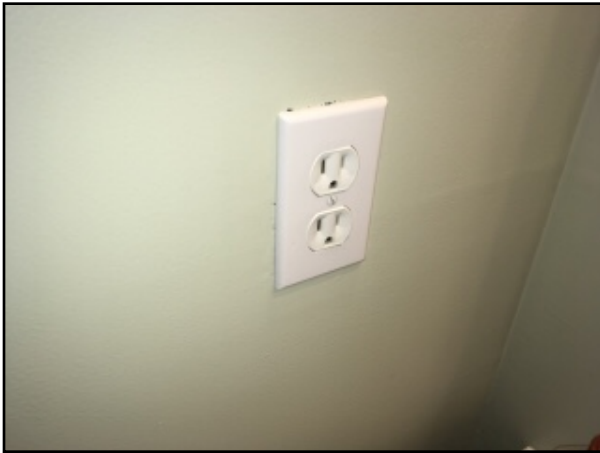
Figure 90-1

Missing GFCI - Non-ground fault circuit interrupting outlet adjacent sink. For electrical safety, recommend replacing with GFCI device.

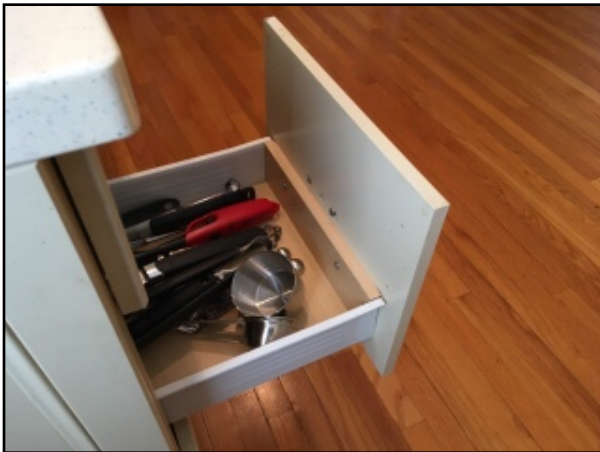
Figure 93-1

Comment 93:
Loose drawer front.

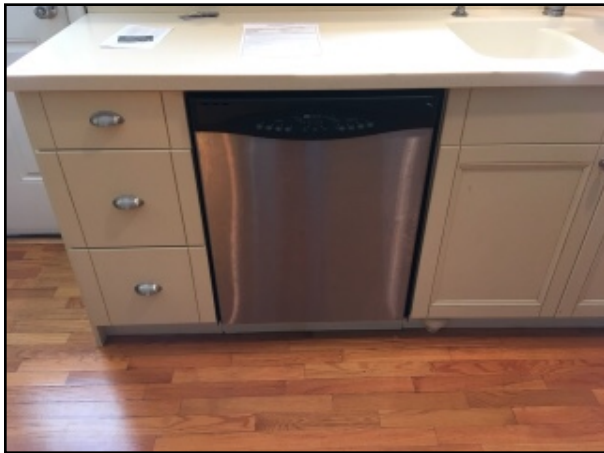
Figure 94-1

**Comment 94:**
15 year old dishwasher. Some parts of the wire baskets had rusted through.

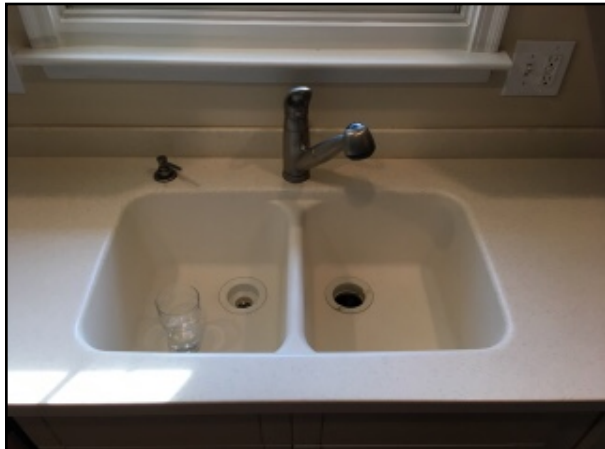
Figure 95-1

Double bowl, integral sink with pull out spray handle faucet and garbage disposal. Missing drain stoppers and heat damaged strainer. Evidence of prior leak.

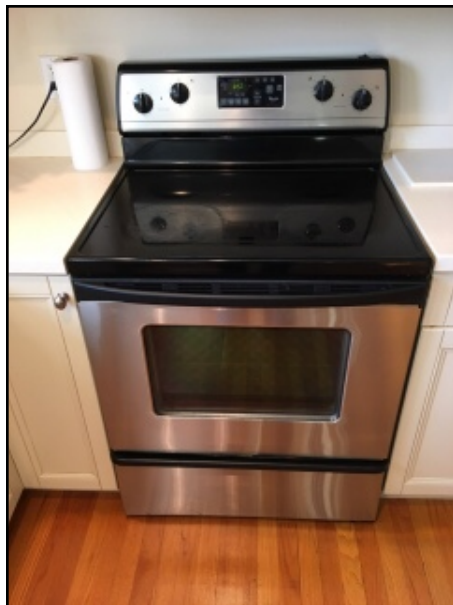
Figure 96-1

14 year old oven. Warming drawer missing screw.

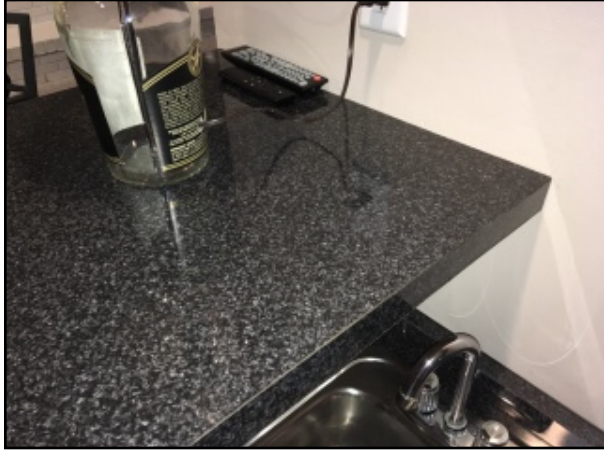
Figure 99-1

Bar top in basement not adequately fixed in place. Recommend adding support.

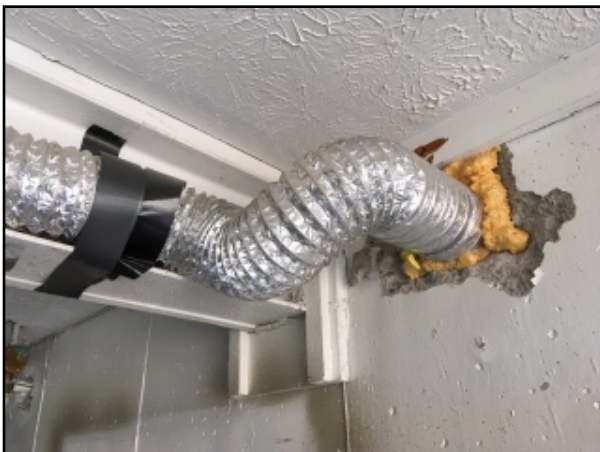
Figure 102-1

Flexible aluminum dryer vent - This type of material is not recommended for dryer venting as the ridges inside catch lint allowing it to build up restricting airflow causing the dryer to run inefficiently as well as an increase of fire risk. Recommend replacing with smooth wall dryer vent piping.

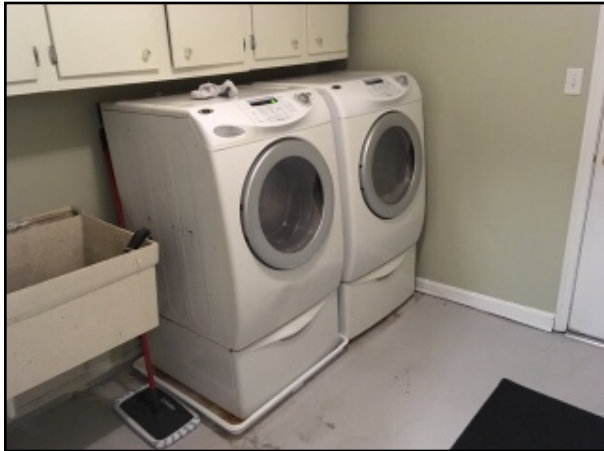
Figure 104-1

13 year old washer and dryer set. Washer appears to be under recall due to leaks.

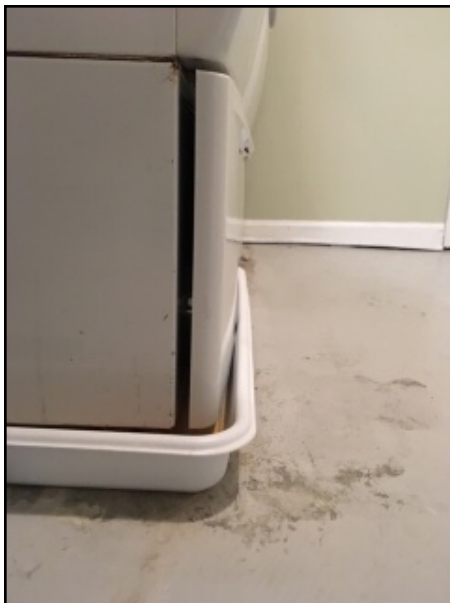
Figure 106-1

Washing machine was set inside a catch pan which is good in case of league, however this prevents the drawer base from being able to open. Recommend setting the drawer base on 2 x 4's or other spacers to raise it up to the point where the base drawer could be used.

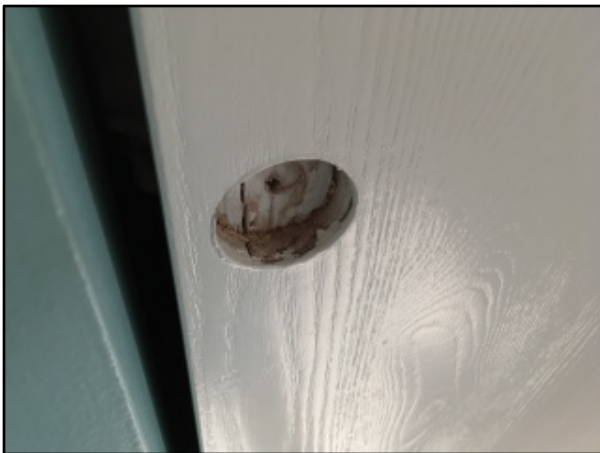
Figure 108-1

Comment 108:
Missing finger pulls on bypass closet doors.

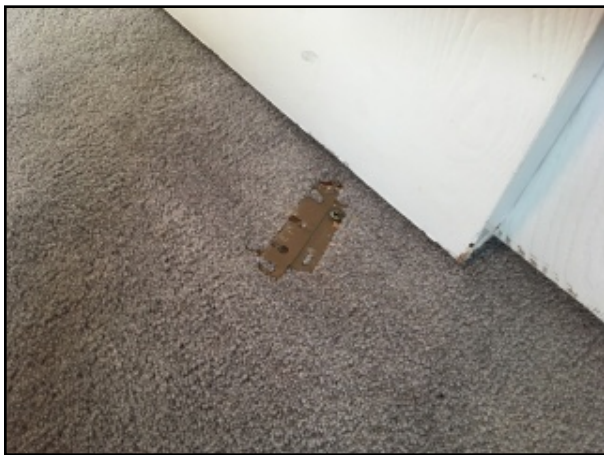
Figure 112-1

Comment 112:
Bypass closet door missing bottom guides.

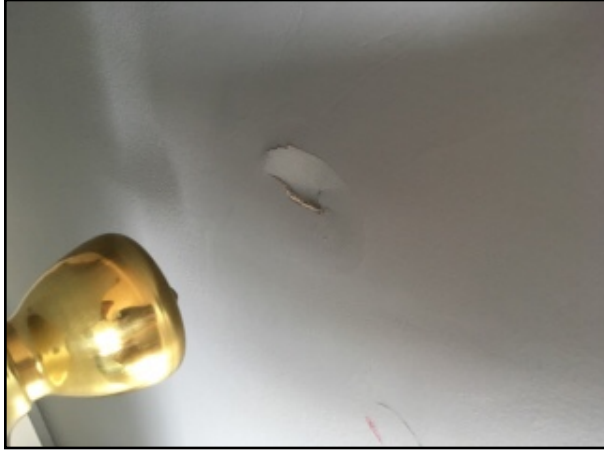
Figure 113-1

Comment 113:
Drywall damage by door knob. Cosmetic defect.

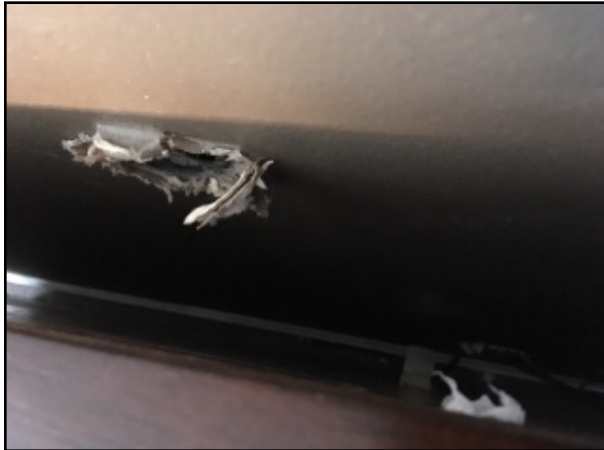
Figure 116-1

Comment 116:
Holes in drywall behind dresser in master bedroom. Cosmetic defect.

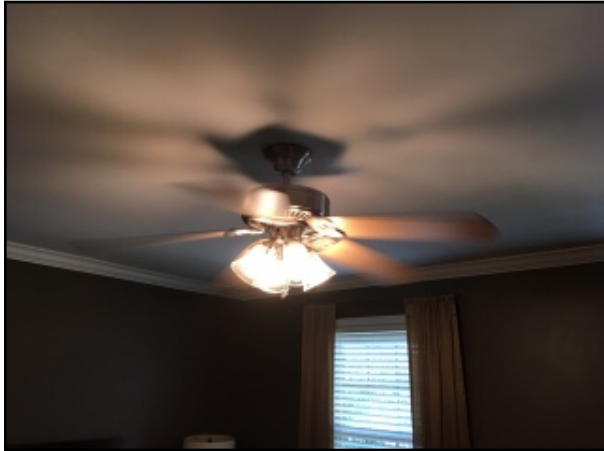
Figure 117-1

Ceiling fan with light in master bedroom. Fan speed is difficult to select due to missing bushing on pull chain.

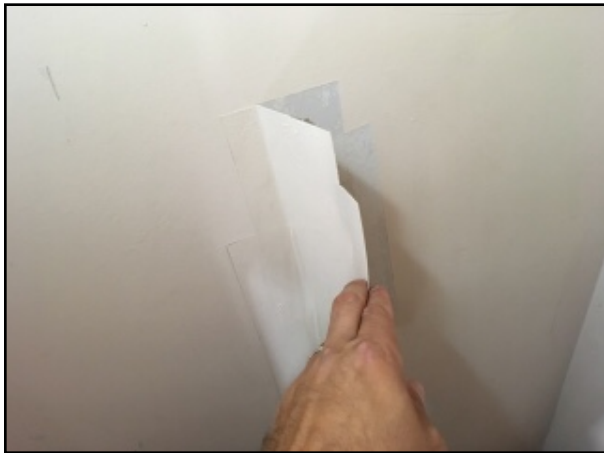
Figure 118-1

Taped section of drywall where tape is coming off. Cosmetic defect.

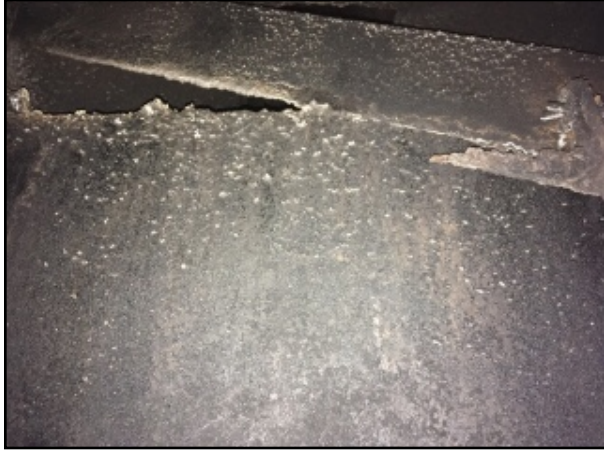
Figure 121-1

The damper is not functional. Recommend repair by qualified chimney repair man.
