Home Inspection Report

123 Sample Lane

Sample , KY 12345

Inspected on Thu, Jul 19 2018 at 8:00 AM

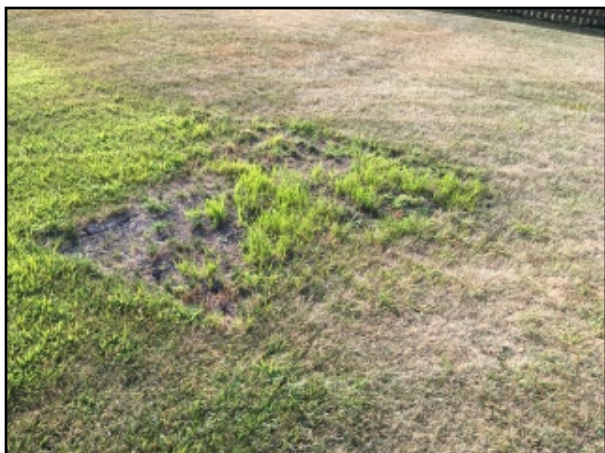
Figure 5-1

Low spot in yard - Area may hold water in times of heavy rainfall.

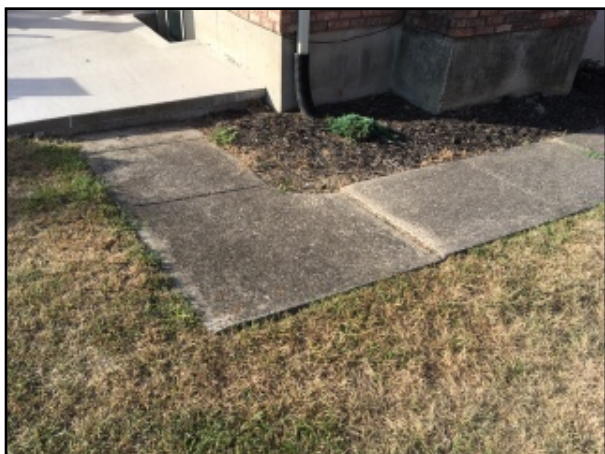
Figure 6-1

Low spot in sidewalk - Area may hold water or snow melt. Use caution in freezing weather.

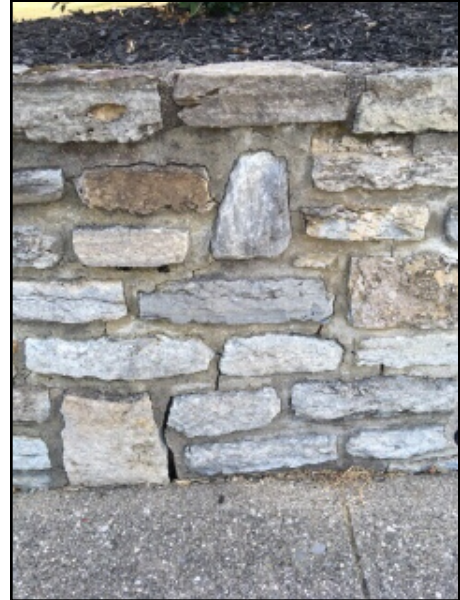
Figure 7-2

Loose/missing mortar - Recommend an experienced mason seal cracks and replace missing mortar to prevent further damage due to freeze/thaw cycle.

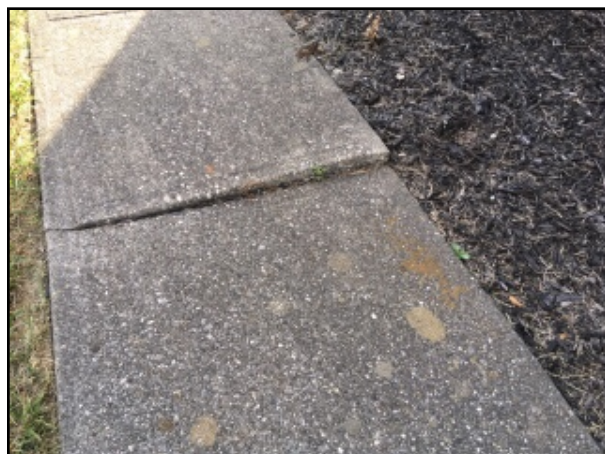
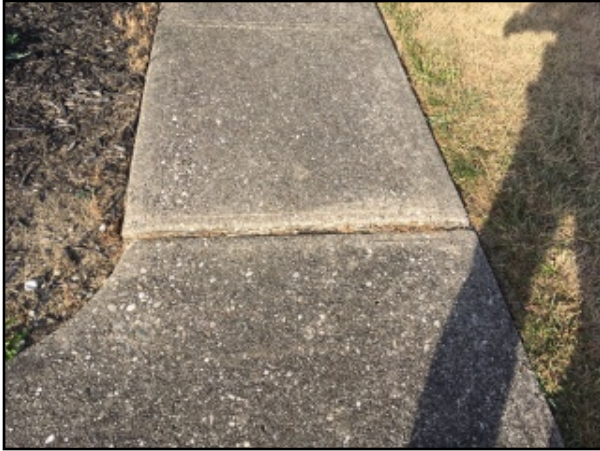
Sidewalk trip hazard/s - safety concern especially for the elderly and children. Recommend replacement, grinding or concrete lifting to eliminate this hazard.

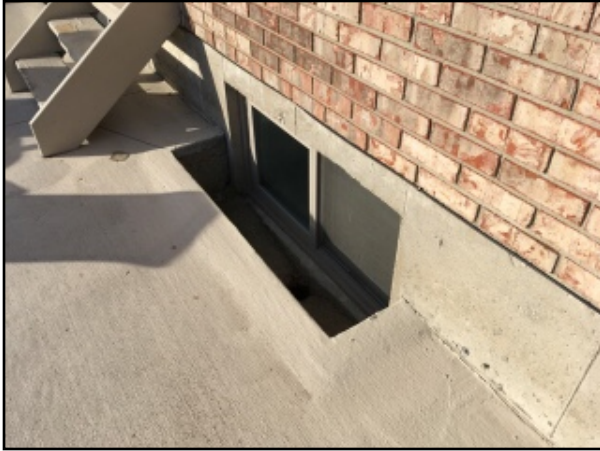
Figure 10-1

The two window wells in the patio are a potential hazard for the elderly and children if they are unaware of the well. While the depth of the well is less than 2 feet and doesn't require a railing, given the wells are within the walking surface of the patio they may not be as easily noticed. Preach caution.

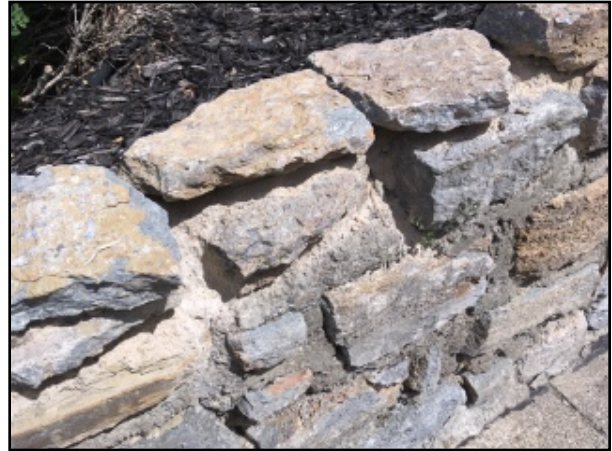
Figure 12-2

Loose retaining wall stone/s-recommend an experienced mason make repairs.
Evidence of prior repair.

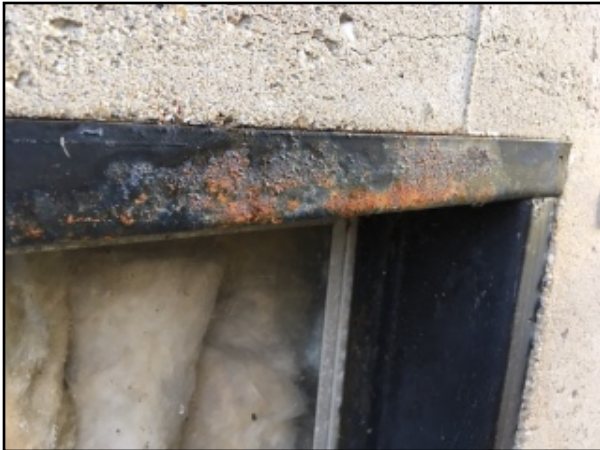
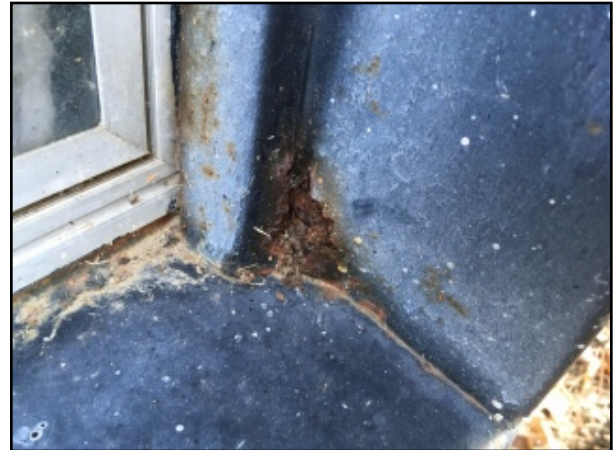
Rusty basement window opening form - recommend prep and paint to prevent further deterioration.

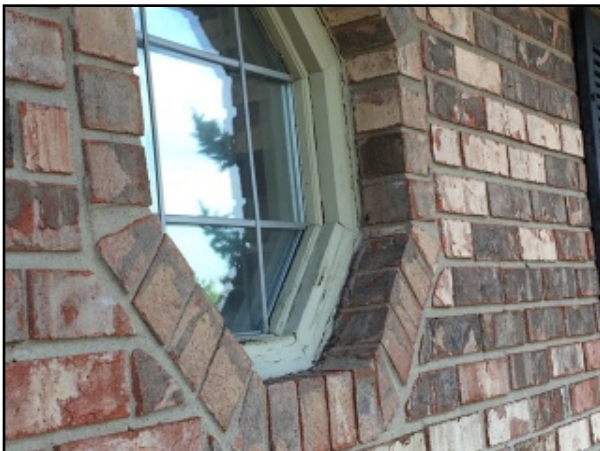
Figure 15-1

Wood window deterioration - recommend prep and paint to prevent further deterioration.

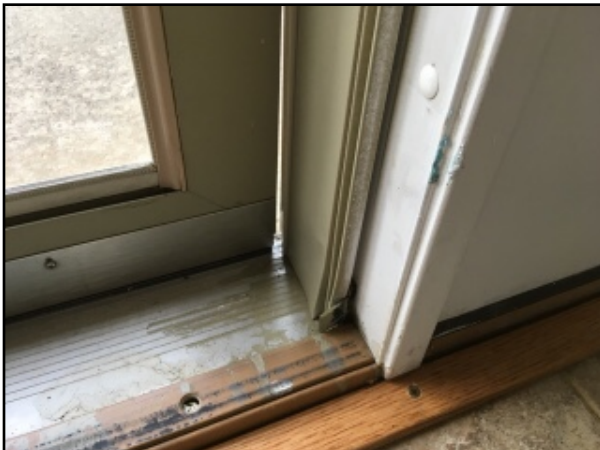
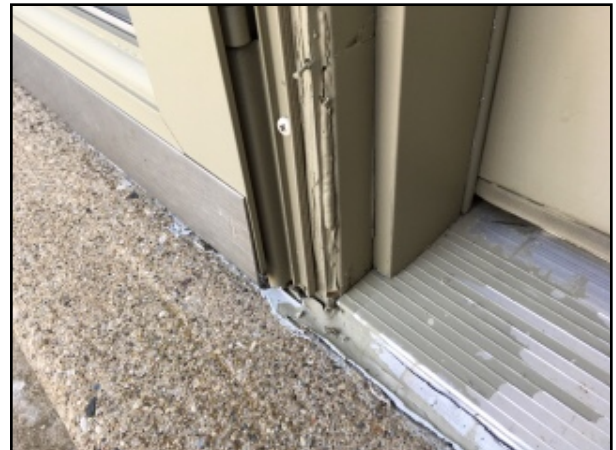
Loose jamb extension - The jamb extension to which the storm door is hung, is loose and allowing the storm door to sag, creating a gap at the bottom and top corners. Recommend repair by qualified carpenter.

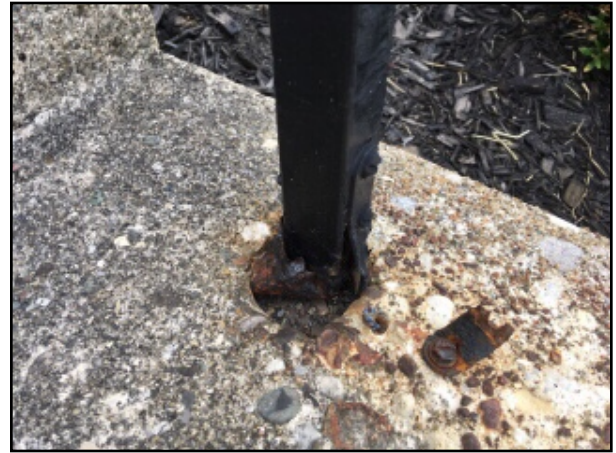
Figure 19-2

Rusty railing posts - The bottom of the railing posts are rusting away causing the railing to lose strength. Recommend repair or replace.

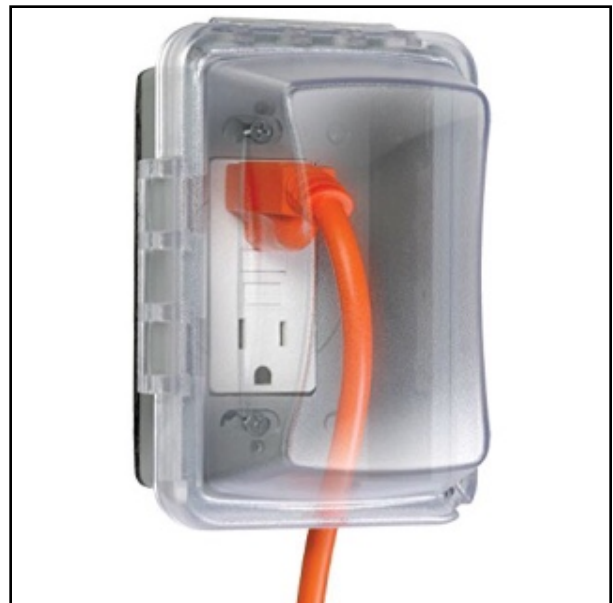
Figure 20-2

No power at exterior outlet. Unable to test for ground fault circuit interrupting device protection. Recommend inquiring with homeowner as to whether there may be a switch or an unlocated GFCI outlet that was already tripped. Recommend weatherproof-while-in-use type "bubble" cover. See photo example.

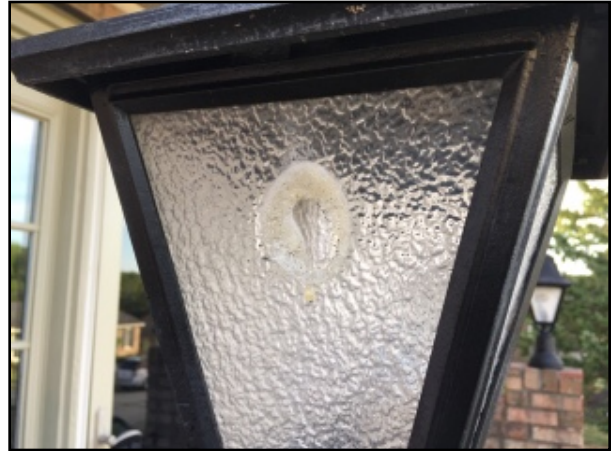
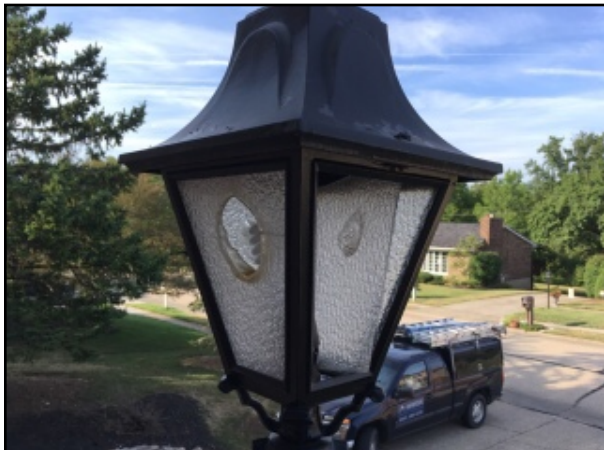
**Comment 21:**
Melted light fixture len/s- Likely a bulb of too high of wattage was used, and overheated the len/s. Recommend replacement.

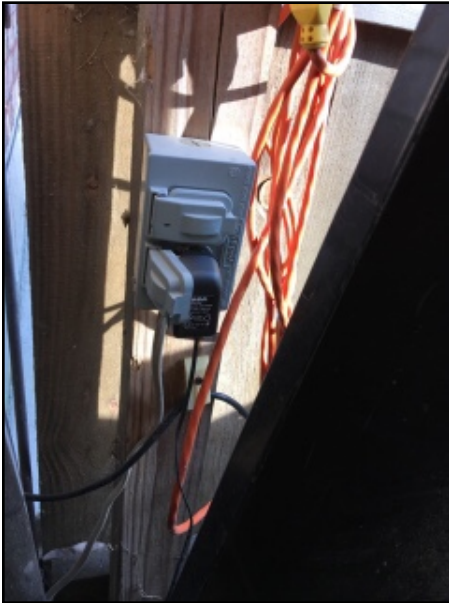
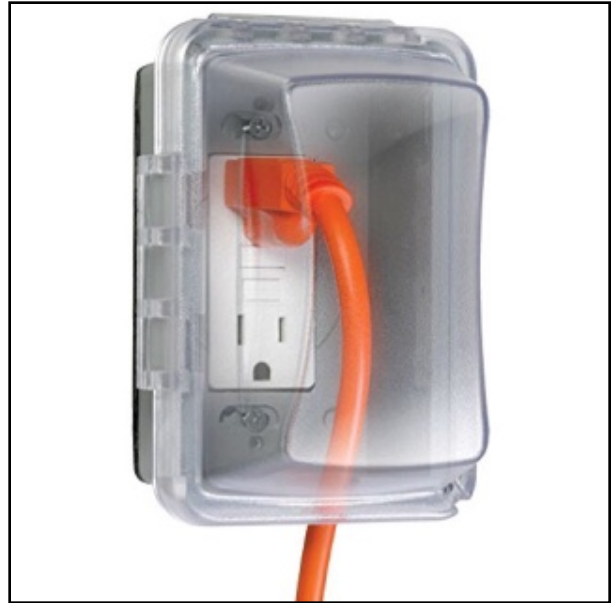
Non-ground fault circuit interrupting device protected exterior outlet - recommend replacing with GFCI outlet. Recommend weatherproof-while-in-use type "bubble" cover. See photo example.

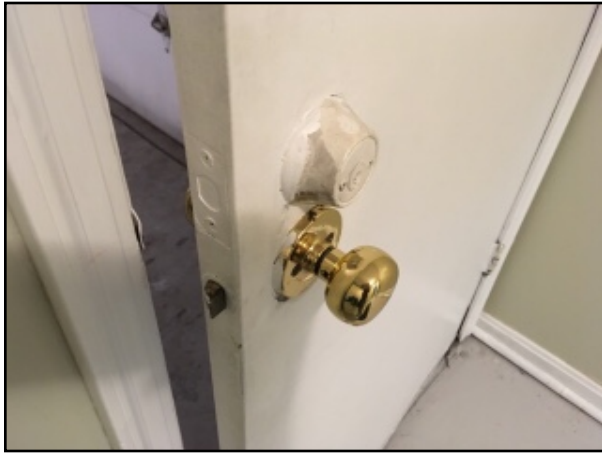
Figure 31-1

Comment 31:
Non-functional deadbolt.

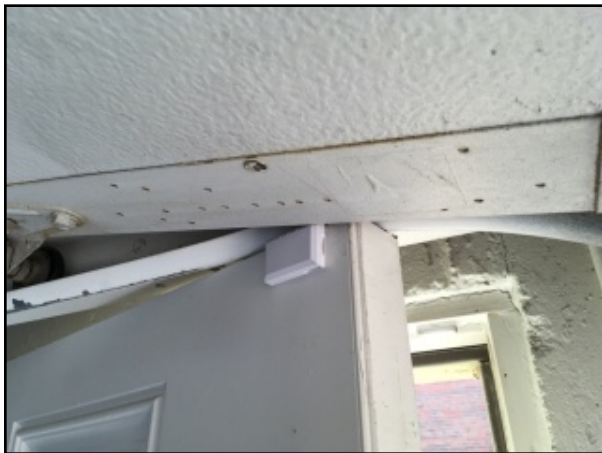
Figure 32-1

Side door to the garage strikes garage door when garage door is in open position. Side door can only be opened when garage door is closed.

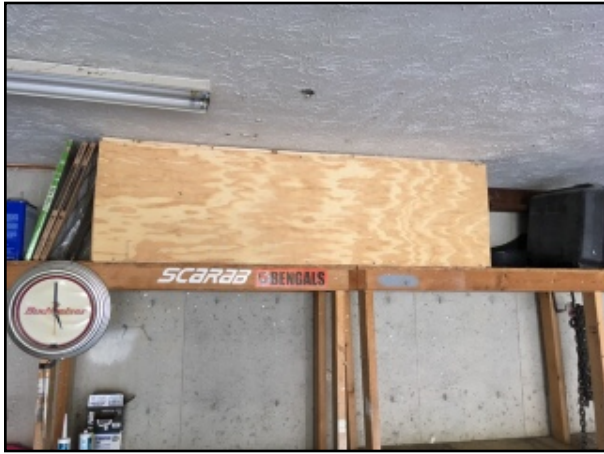
Figure 33-1

Odd box, not readily openable. Unidentifiable purpose.

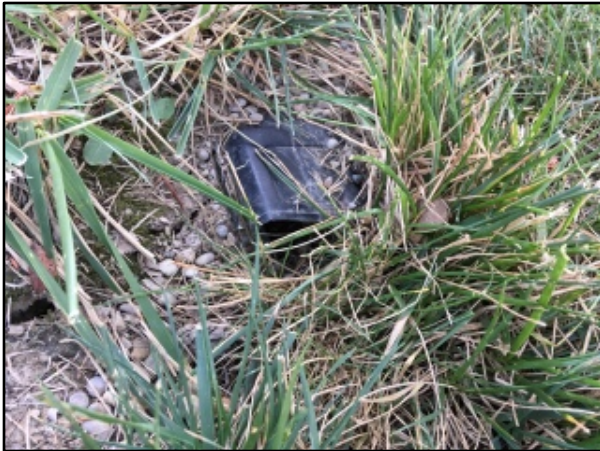
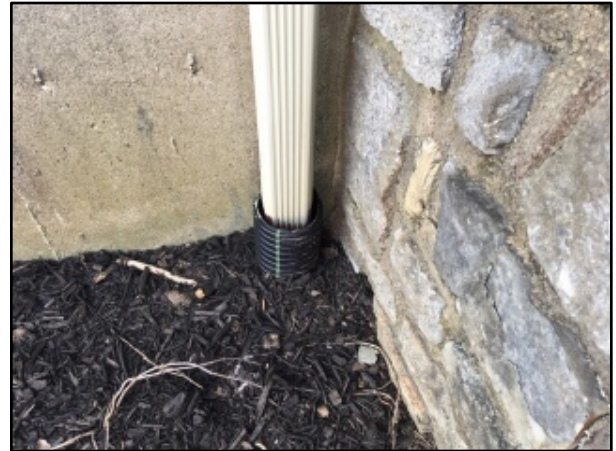
Downspouts discharge into underground piping which, presumably carries the water away from house and "daylights" out in the yard. This is good.

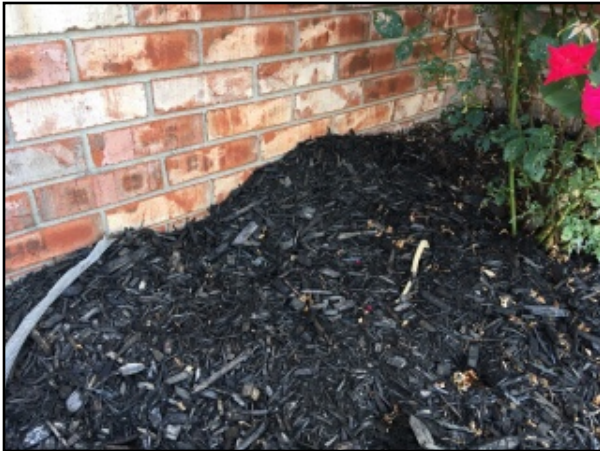
Figure 41-1

High mulch - The mulch in this area is covering the brick veneer. This may allow run off to soak into the brick and mortar and not properly drain away from the house. Recommend lowering the grade to 6 inches below the bottom of the brick.

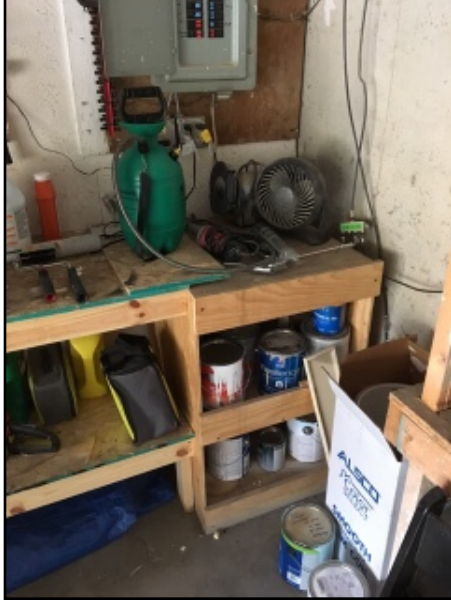
Figure 44-1

Electric panel not readily accessible - recommend keeping the area in front of the electric panel clear for access to work on it safely.

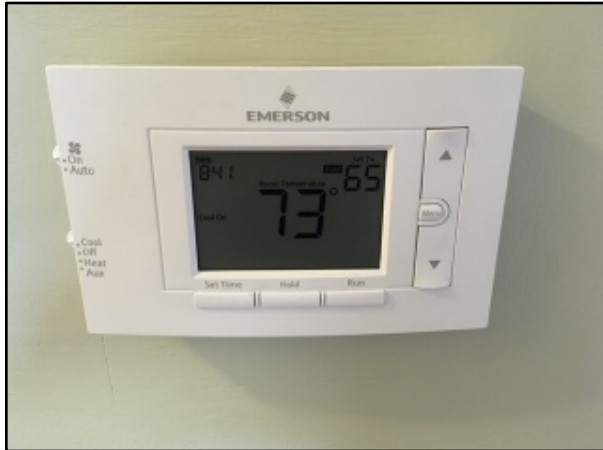
Figure 55-1

Comment 55:
Programmable thermostat in the main floor hallway.

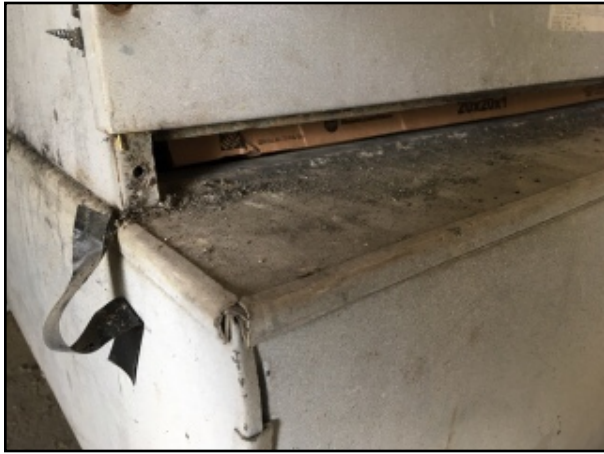
Figure 57-1

Comment 57:
Filter access at the bottom of the a coil section. Filter was difficult to remove.

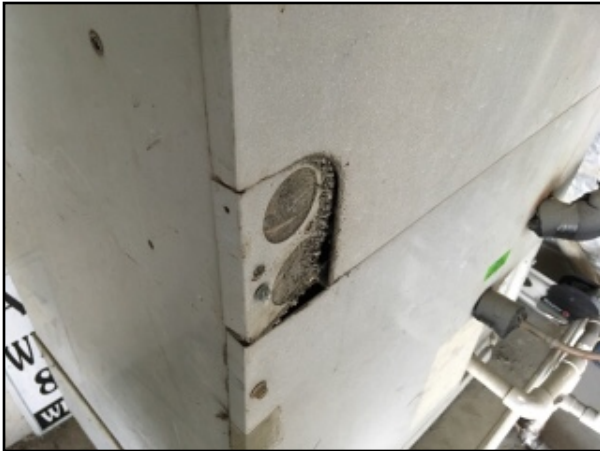
Figure 59-1

Air handler in garage - It is not recommended that the heating and cooling air handler be located in the garage as fumes and odors from the garage are likely to be carried into the house by the air handler. If possible, it is recommended a wall be constructed to separate the garage from the air handling equipment.

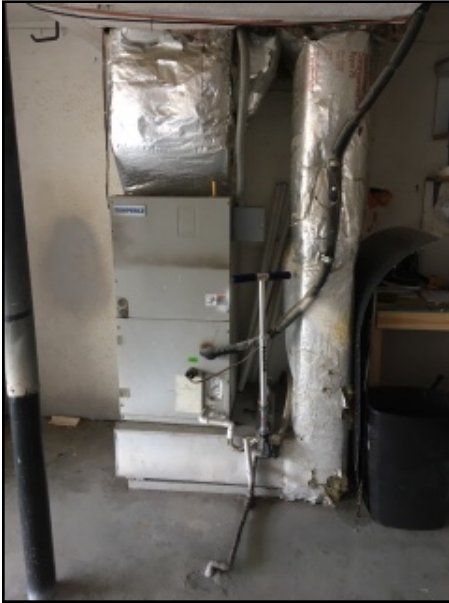
Figure 61-1

Comment 61:
Heating and cooling air handler.

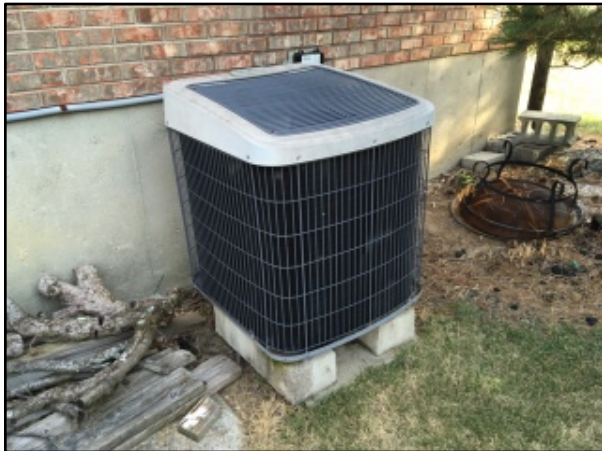
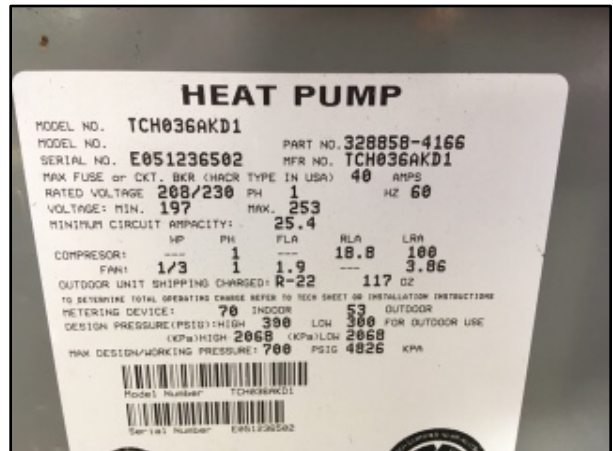
Type of Equipment: Central AC
 Condition: Performing intended function
 Condenser Approximate Age: 13 Years, Nearing End Of Expected Useful Life

i Comment 63:
 AC life - The average useful life for an air conditioner is 15-20 years.

i Comment 64:
 Condensing unit/heat pump.

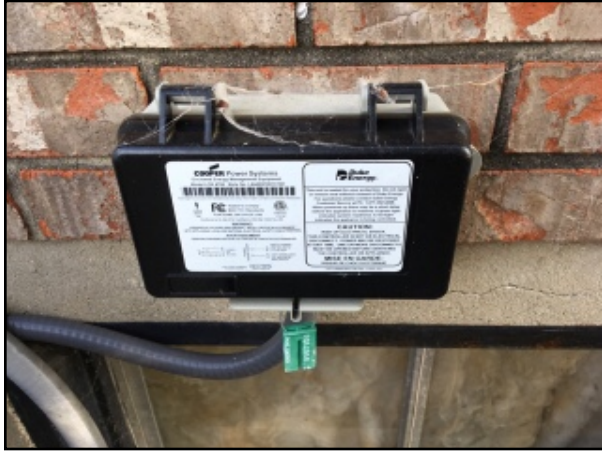
Figure 65-1

Electrical utility remote control brown out device - this device is optional and gives the electrical utility the ability to temporarily shut off your air conditioning in times of high electrical demand.

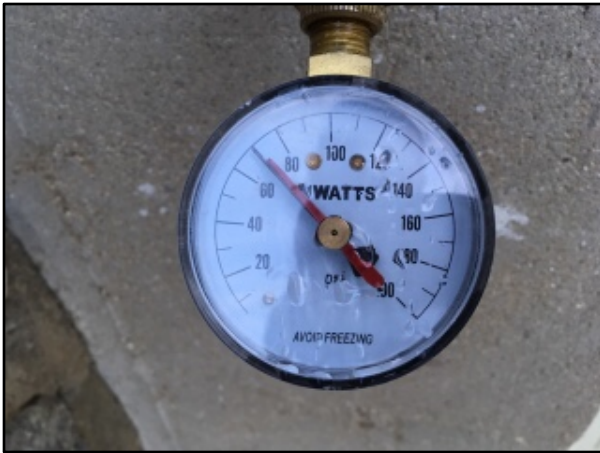
Figure 66-1

Recommended water pressure is between 45 and 65 psi. High water pressure can cause premature failure in automatic water valves in dishwashers, clothes washers and toilets.

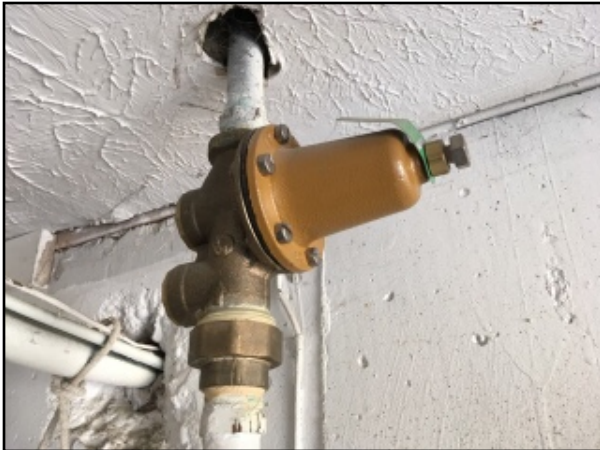
Figure 67-1

Pressure reducing valve - this device allows the adjustment of the water pressure in the home.

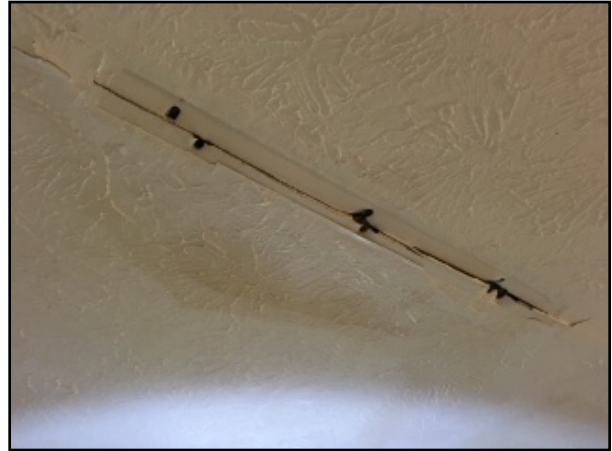
Figure 69-2

Stained and water damaged drywall on ceiling of garage below master bath. Drywall has sagged and shows evidence of possible fungal growth. Tested with moisture meter and found to be currently dry. Check sellers disclosure for knowledge of previous plumbing leaks. Possible concealed damage. Recommend removal of drywall, further inspection for damage and drywall repair.

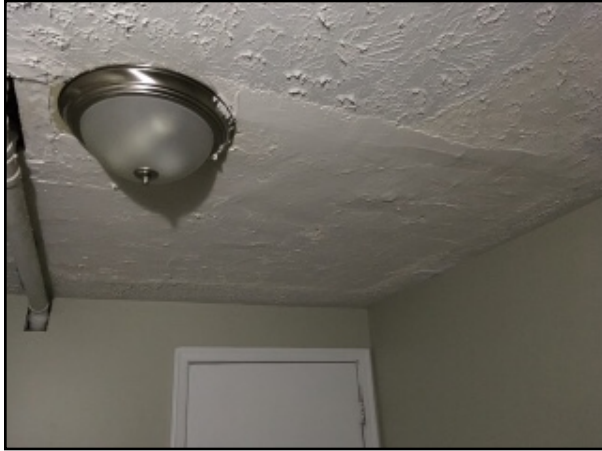
Figure 70-1

Evidence of significant patching of drywall ceiling below master bathroom. Tested with moisture meter and found currently dry. Possible hidden defects.

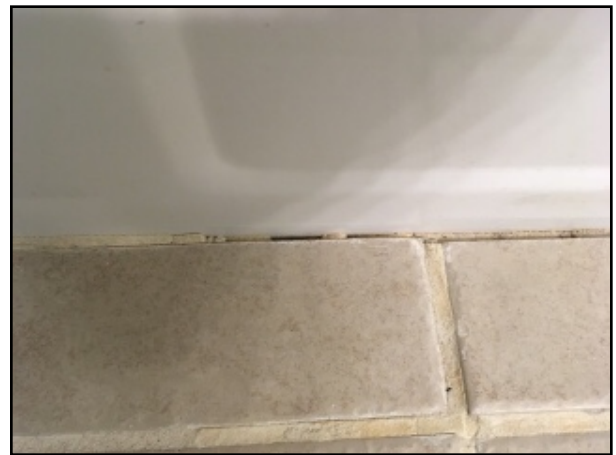
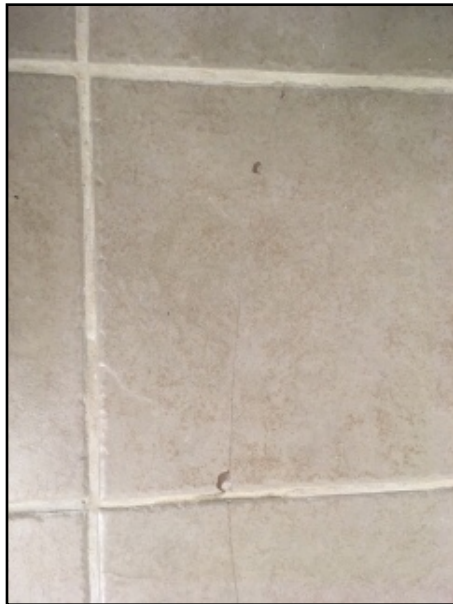
Several cracks in floor tile, cracked grout and missing grout/caulking.

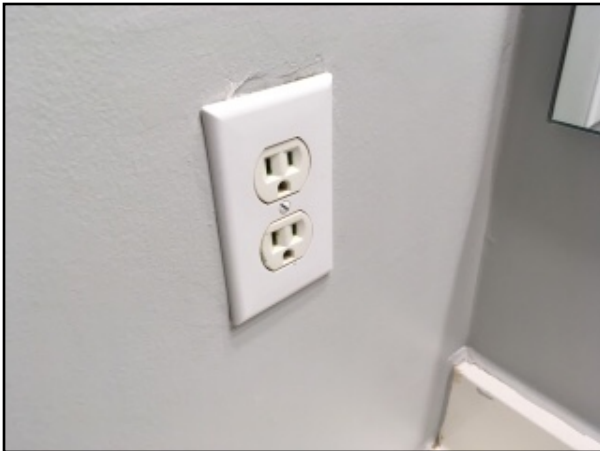
Figure 78-1

Missing GFCI - Non-ground fault circuit interrupting outlet adjacent sink. For electrical safety, recommend replacing with GFCI device.

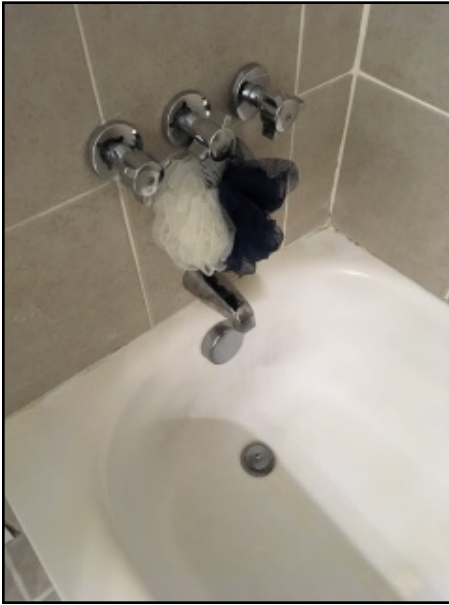
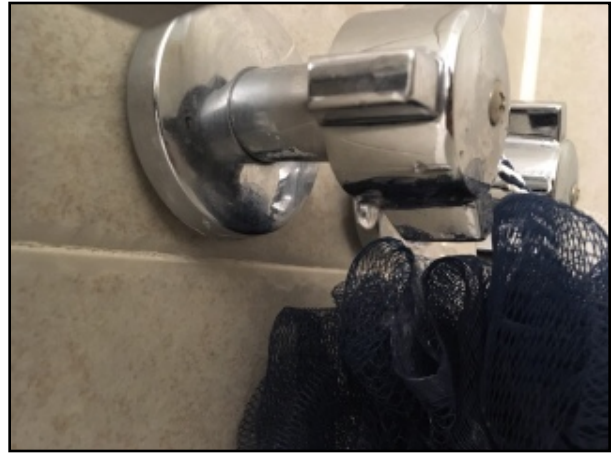
Non-pressure balancing tub/shower faucet. Sudden drop in cold water flow (from a toilet flush potentially) may cause temperature spike of tub/shower. Exercise caution to avoid unpleasant experience and be sure to keep water heater thermostat at 120 degrees F or less. Leaking shower diverter. Recommend repair

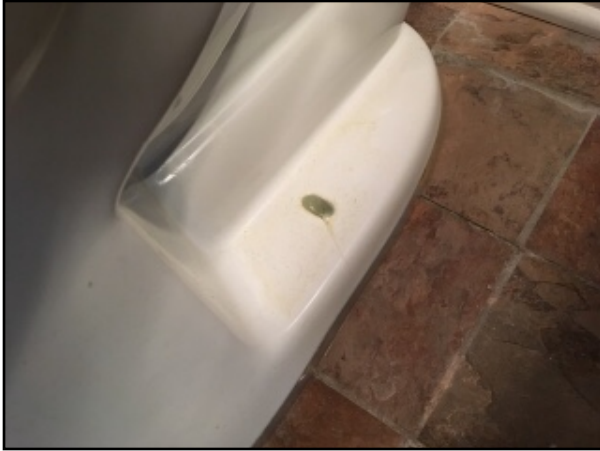
Figure 82-1

The toilet is not fastened to the flange with appropriate bolts. The toilet appears to be adhered with silicone only. Recommend installing toilet bolts.

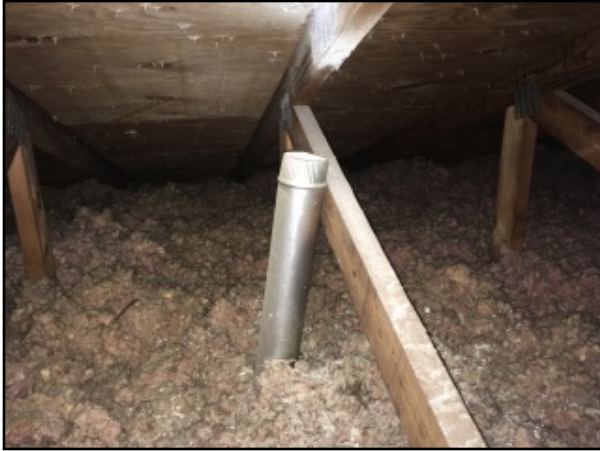
Figure 87-1

Vents to attic - The bathroom ventilator was discharging into the attic space. This may lead to condensation on attic surfaces and potential fungal growth. It is recommended that bathroom ventilators discharge to the exterior.

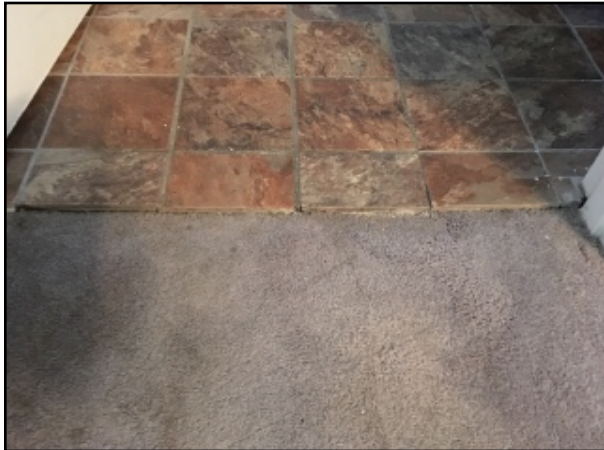
Figure 88-1

Missing carpet to tile transition. Cosmetic defect

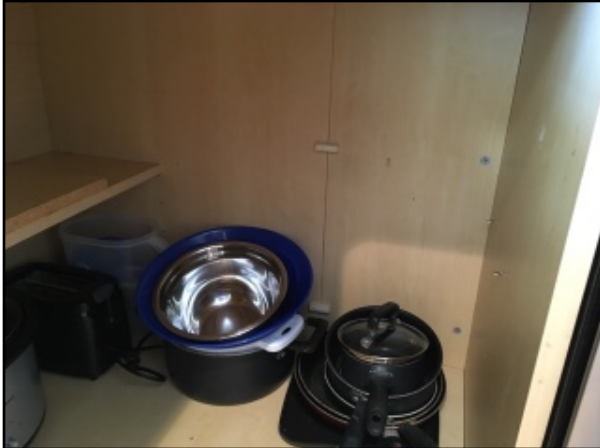
Figure 92-1

Comment 92:
Missing shelf inside corner cabinet.

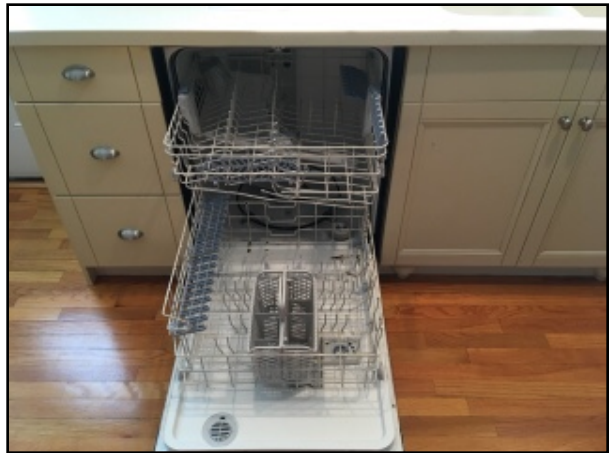
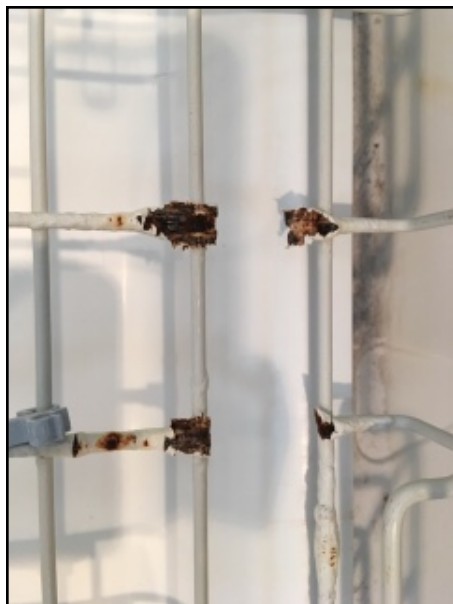
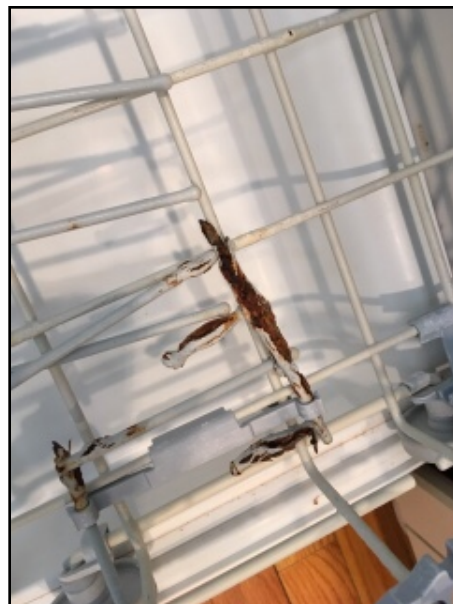
**Comment 94:**
15 year old dishwasher. Some parts of the wire baskets had rusted through.

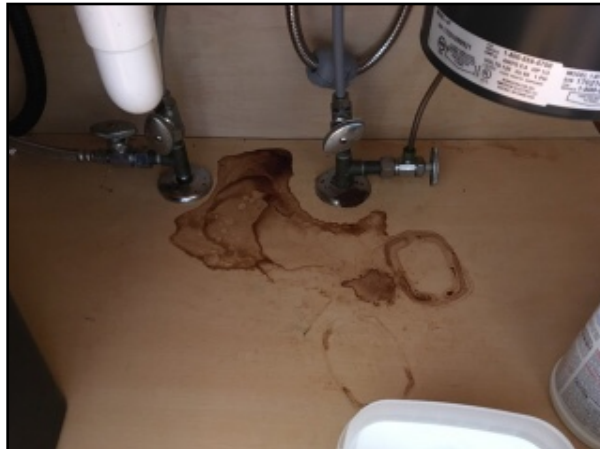
Figure 95-2

Double bowl, integral sink with pull out spray handle faucet and garbage disposal. Missing drain stoppers and heat damaged strainer. Evidence of prior leak.

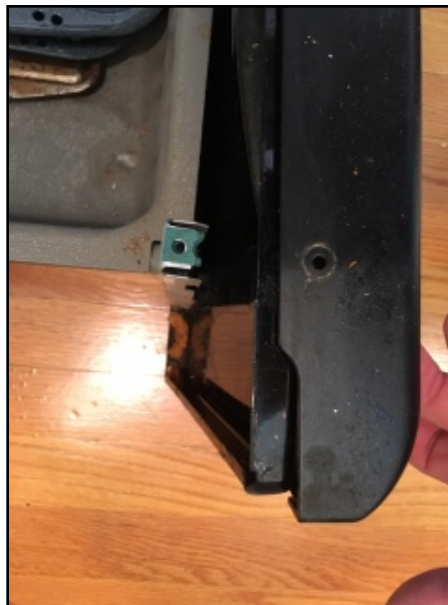
Figure 96-2

14 year old oven. Warming drawer missing screw.

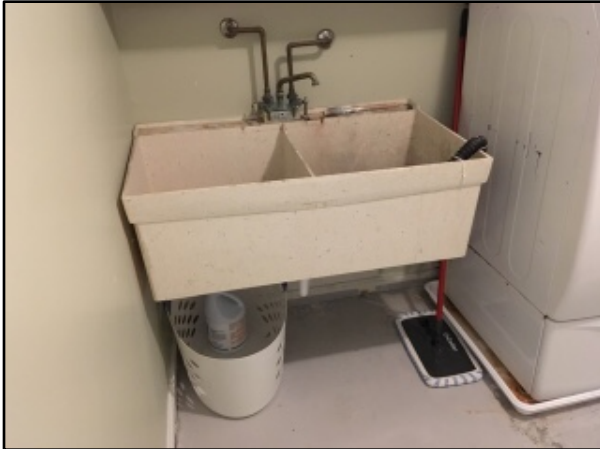
Figure 100-1

Missing drain stoppers. Missing utility sink legs. Be careful not to fill sink too high or put too much weight on the sink which is only mounted to the wall. Recommend adding legs.

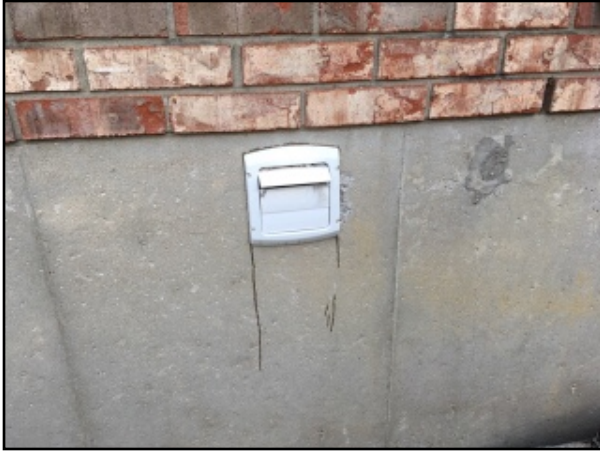
Figure 101-1

Dryer vent louver didn't open with dryer running. Dryer vent may be clogged. Wasp nest visible inside vent. Recommend replacing vent with smooth wall vent piping.

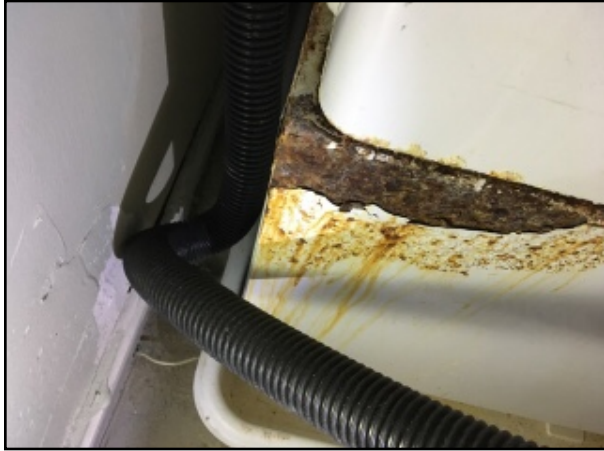
Figure 105-1

Washing machine base was rusty. Suspected washing machine leak. It appears to be under recall. Recommend repair or replace

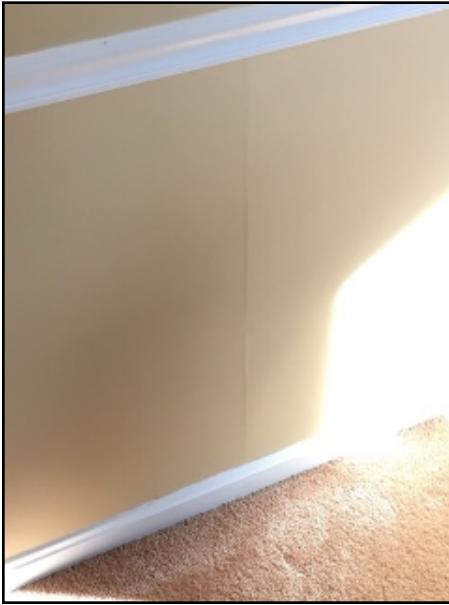
Figure 111-1

Comment 111:
Visible drywall seam. Cosmetic defect.

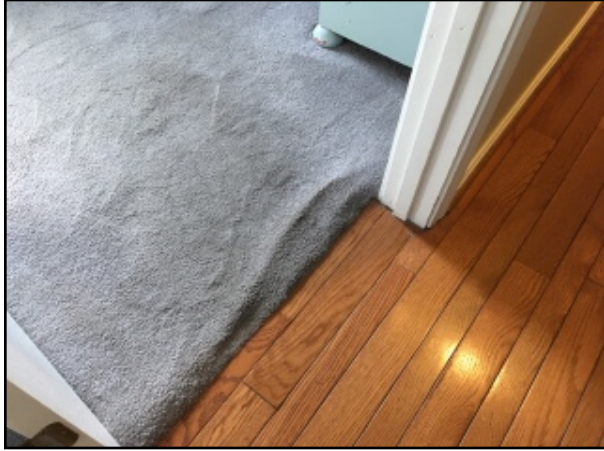
Figure 115-1

Comment 115:
Carpet in need of re-stretching.

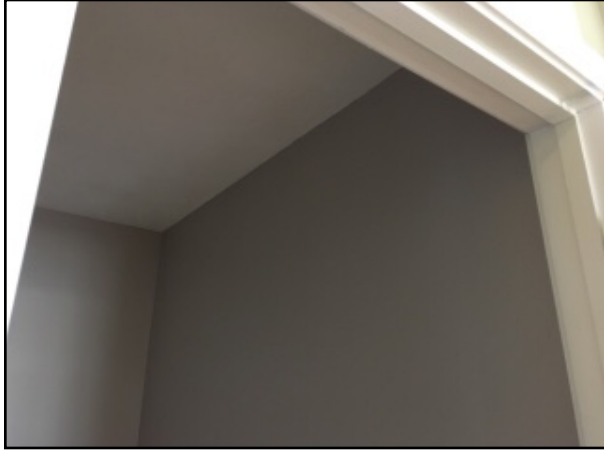
Figure 119-1

Comment 119:
Top of stairway doesn't have a light. Stairway is dark with door closed.

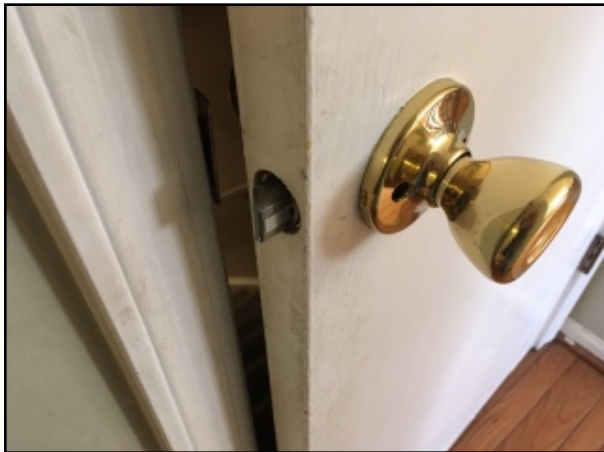
Figure 120-1

Comment 120:
Door to basement doesn't latch. Safety concern for small children.

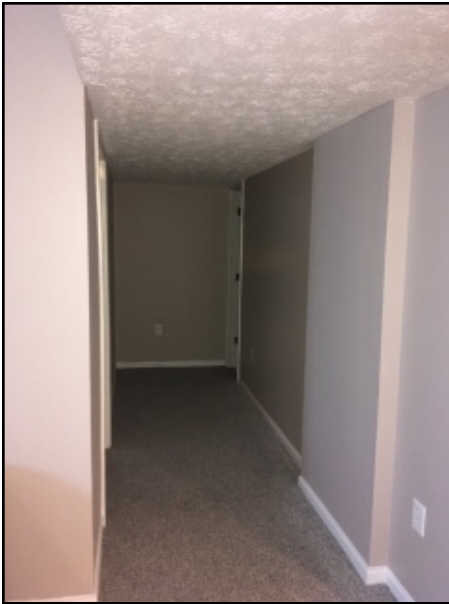
Figure 122-1

Comment 122:

Dark hallway.
